Access Compliance Report
Public Rights-of-Way
(Curb Ramps)

Intersection ID: 15096	Main Street: OLMSTED_PARK_PL	Cross Street: WINTHROP_AV	Location:	SW
ADA ID: 6555A44B8FFE	Ramp Type: PerpDiag	Initial Pass/Fail: Fail	Overall Compliance: No	Severity Score: 25

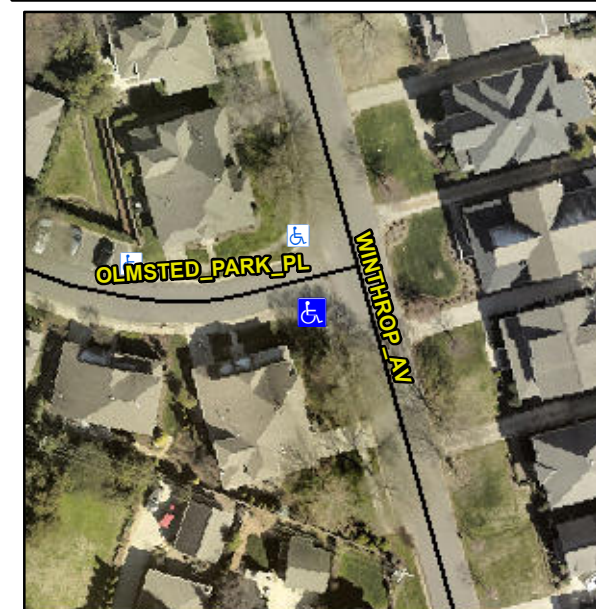
Not Found, R304.2.2, R304.5.3

Compliance	Description	Data	Compliance	Description	Data
N/A	Ramp Length (in)	51.0	No	Ramp Slope (%)	8.7
Yes	Ramp Width (in)	67.0	No	Ramp XSlope (%)	5.5
N/A	Flare Type LT	N/A	N/A	Flare Type RT	N/A
N/A	Flare Slope LT (%)	N/A	N/A	Flare Slope RT (%)	N/A
N/A	Flare Traversable LT?	N/A	N/A	Flare Traversable RT?	N/A
N/A	Landing Length (in)	N/A	N/A	DWS Provided?	N/A
N/A	Landing Width (in)	N/A	N/A	DWS Contrast?	N/A
N/A	Landing Slope (%)	N/A	N/A	DWS Length (in)	N/A
N/A	Landing X Slope (%)	N/A	N/A	DWS Full Width?	N/A
N/A	Landing Curb? (Y/N)	N/A	N/A	DWS Offset (in)	N/A
N/A	Shared Landing?	N/A			
N/A	Gutter Ponding?	N/A	N/A	Gutter Slope (%)	N/A
N/A	Gutter Lip Ht (in)	N/A	N/A	Gutter X Slope (%)	N/A
N/A	Painted X Walk1?	No	N/A	Painted X Walk2?	No
	X Walk 1 Direction	To E		X Walk 2 Direction	To N
N/A	X Walk 1 Width (in)	N/A	N/A	X Walk 2 Width (in)	N/A
	X Walk 1 Slope (%)	2.8		X Walk 2 Slope (%)	1.7
	X Walk 1 X Slope (%)	2.3		X Walk 2 X Slope (%)	1.4

Remove & Replace Curb Ramp With Two New Directional Ramps or Equivalent.
