Access Compliance Report

# Public Rights-of-Way
(Curb Ramps)

Intersection ID: 10021862	**Main Street:** BROADFORD_CT	**Cross Street:** N/A	**Location:**	**NE**
ADA ID: 6671C2BA4773	**Ramp Type:** Perp	**Initial Pass/Fail:** Fail	**Overall Compliance:** No	**Severity Score:** 50

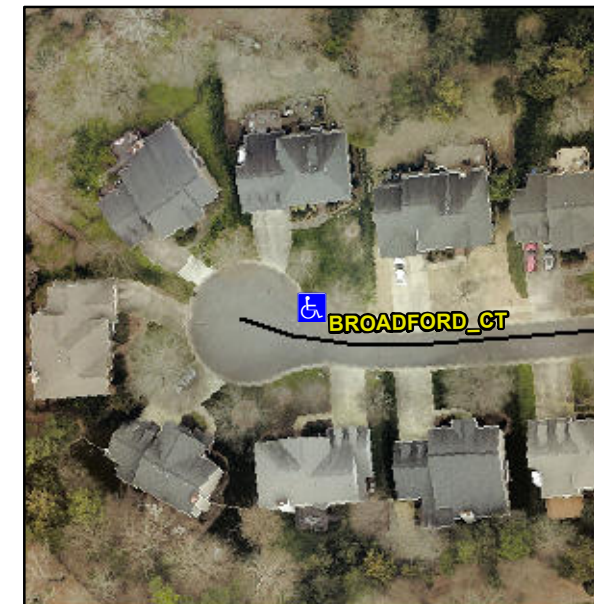
R304.2.2, R304.5.3

Compliance	Description	Data	Compliance	Description	Data
N/A	Ramp Length (in)	42.0	No	Ramp Slope (%)	14.9
Yes	Ramp Width (in)	48.0	No	Ramp XSlope (%)	9.0
N/A	Flare Type LT	N/A	N/A	Flare Type RT	N/A
N/A	Flare Slope LT (%)	N/A	N/A	Flare Slope RT (%)	N/A
N/A	Flare Traversable LT?	N/A	N/A	Flare Traversable RT?	N/A
N/A	Landing Length (in)	N/A	N/A	DWS Provided?	N/A
N/A	Landing Width (in)	N/A	N/A	DWS Contrast?	N/A
N/A	Landing Slope (%)	N/A	N/A	DWS Length (in)	N/A
N/A	Landing X Slope (%)	N/A	N/A	DWS Full Width?	N/A
N/A	Landing Curb? (Y/N)	N/A	N/A	DWS Offset (in)	N/A
N/A	Shared Landing?	N/A			
N/A	Gutter Ponding?	N/A	N/A	Gutter Slope (%)	N/A
N/A	Gutter Lip Ht (in)	N/A	N/A	Gutter X Slope (%)	N/A
N/A	Painted X Walk1?	No	N/A	Painted X Walk2?	N/A
	X Walk 1 Direction	To SW		X Walk 2 Direction	N/A
N/A	X Walk 1 Width (in)	N/A	N/A	X Walk 2 Width (in)	N/A
	X Walk 1 Slope (%)	0.4		X Walk 2 Slope (%)	N/A
	X Walk 1 X Slope (%)	2.9		X Walk 2 X Slope (%)	N/A

Remove & Replace Entire Ramp.
