Access Compliance Report
Public Rights-of-Way
(Curb Ramps)

Intersection ID: 29119	**Main Street: CRISP_WOOD_LN**	**Cross Street: HIGHLAND_PARK_DR**	**Location:** E
ADA ID: 69D8A7BBE9B2	**Ramp Type: BlendTrans1**	**Initial Pass/Fail: Fail** **Overall Compliance: No**	**Severity Score: 10**

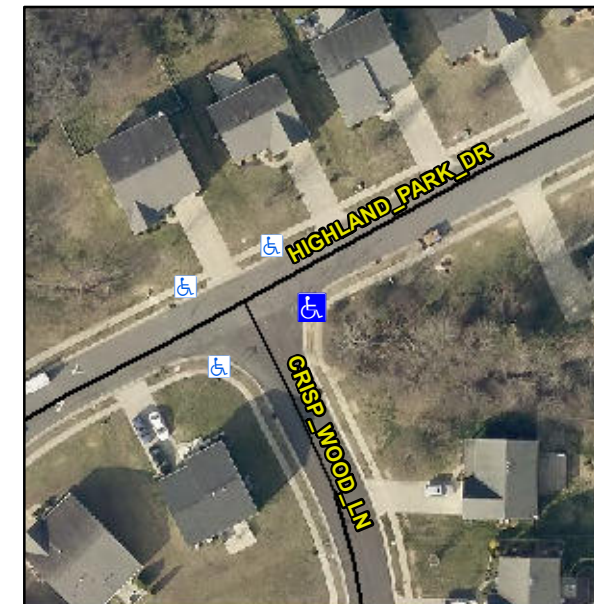
GAS VALVE LOCATED IN DWS

Not Found, R304.5.1, R304.5.3

Compliance	Description	Data	Compliance	Description	Data
N/A	Ramp Length (in)	48.0	Yes	BlendTrans Slope (%)	1.7
No	Ramp Width (in)	42.0	No	BlendTrans XSlope (%)	3.0
N/A	Flare Type LT	N/A	N/A	Flare Type RT	N/A
N/A	Flare Slope LT (%)	N/A	N/A	Flare Slope RT (%)	N/A
N/A	Flare Traversable LT?	N/A	N/A	Flare Traversable RT?	N/A
N/A	Landing Length (in)	N/A	N/A	DWS Provided?	N/A
N/A	Landing Width (in)	N/A	N/A	DWS Contrast?	N/A
N/A	Landing Slope (%)	N/A	N/A	DWS Length (in)	N/A
N/A	Landing X Slope (%)	N/A	N/A	DWS Full Width?	N/A
N/A	Landing Curb? (Y/N)	N/A	N/A	DWS Offset (in)	N/A
N/A	Shared Landing?	N/A			
N/A	Gutter Ponding?	N/A	N/A	Gutter Slope (%)	N/A
N/A	Gutter Lip Ht (in)	N/A	N/A	Gutter X Slope (%)	N/A
N/A	Painted X Walk1?	No	N/A	Painted X Walk2?	No
	X Walk 1 Direction	To NW		X Walk 2 Direction	To SW
	X Walk 1 Width (in)	N/A		X Walk 2 Width (in)	N/A
	X Walk 1 Slope (%)	0.6		X Walk 2 Slope (%)	2.8
	X Walk 1 X Slope (%)	2.0		X Walk 2 X Slope (%)	1.0

N/A	Ramp inside XWalk1?	N/A	N/A	Ramp inside XWalk2?	N/A
	Road Slope (%)	1.3		Clear Space?	N/A
	Road X Slope (%)	1.1	N/A	Clear Space to XWalk (in)	N/A
N/A	Any Obstructions?	N/A	N/A	Storm Grate/Utility Hazard?	N/A
	Obstruction Type			Storm Grate/Utility Type	
N/A					N/A
			Yes	Surface Condition? (G/P)	Good
			No	Curb Slope (%)	18.9

Remove & Replace Curb Ramp With Two New Directional Ramps or Equivalent.
