# Access Compliance Report
Public Rights-of-Way
(Curb Ramps)

Intersection ID: 3137	Main Street: ALAMEDA_LN	Cross Street: STONE_PARK_DR	Location:	NE
ADA ID: 6B6E40517752	Ramp Type: PerpDiag	Initial Pass/Fail: Fail	Overall Compliance: No	Severity Score: 8.75

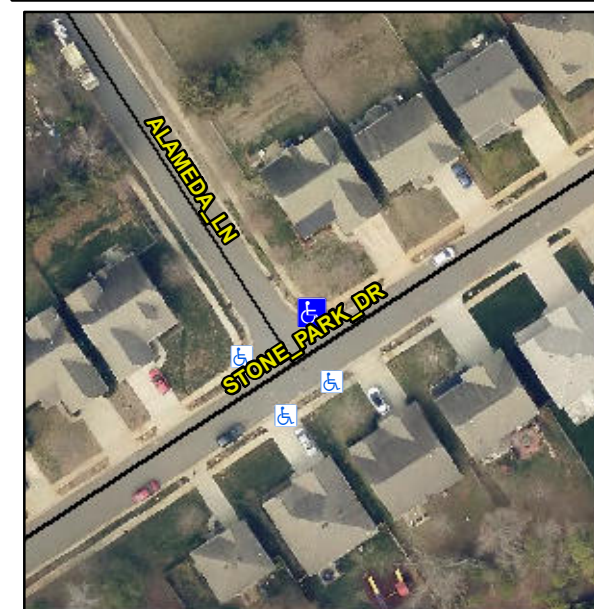
Not Found, R304.5.1

Compliance	Description	Data	Compliance	Description	Data
N/A	Ramp Length (in)	50.0	Yes	Ramp Slope (%)	8.0
No	Ramp Width (in)	37.0	Yes	Ramp XSlope (%)	0.2
N/A	Flare Type LT	N/A	N/A	Flare Type RT	N/A
N/A	Flare Slope LT (%)	N/A	N/A	Flare Slope RT (%)	N/A
N/A	Flare Traversable LT?	N/A	N/A	Flare Traversable RT?	N/A
N/A	Landing Length (in)	N/A	N/A	DWS Provided?	N/A
N/A	Landing Width (in)	N/A	N/A	DWS Contrast?	N/A
N/A	Landing Slope (%)	N/A	N/A	DWS Length (in)	N/A
N/A	Landing X Slope (%)	N/A	N/A	DWS Full Width?	N/A
N/A	Landing Curb? (Y/N)	N/A	N/A	DWS Offset (in)	N/A
N/A	Shared Landing?	N/A			
N/A	Gutter Ponding?	N/A	N/A	Gutter Slope (%)	N/A
N/A	Gutter Lip Ht (in)	N/A	N/A	Gutter X Slope (%)	N/A
N/A	Painted X Walk1?	No	N/A	Painted X Walk2?	No
	X Walk 1 Direction	To W		X Walk 2 Direction	To S
N/A	X Walk 1 Width (in)	N/A	N/A	X Walk 2 Width (in)	N/A
	X Walk 1 Slope (%)	1.0		X Walk 2 Slope (%)	0.4
	X Walk 1 X Slope (%)	0.3		X Walk 2 X Slope (%)	0.8

N/A	Ramp inside XWalk1?	N/A	N/A	Ramp inside XWalk2?	N/A
	Road Slope (%)	0.3	N/A	Clear Space?	N/A
	Road X Slope (%)	0.5	N/A	Clear Space to XWalk (in)	N/A
N/A	Any Obstructions?	N/A	N/A	Storm Grate/Utility Hazard?	N/A
	Obstruction Type			Storm Grate/Utility Type	
N/A					N/A
			Yes	Surface Condition? (G/P)	Good

Remove & Replace Curb Ramp With Two New Directional Ramps or Equivalent.
