Access Compliance Report
Public Rights-of-Way
(Curb Ramps)

Intersection ID: N/A	Main Street: W_POINDEXTER_ST	Cross Street: YOUNGBLOOD_ST	Location: N
ADA ID: 6B6EE1319CCC	Ramp Type: Directional1	Initial Pass/Fail: Fail Overall Compliance: No	Severity Score: 12.5

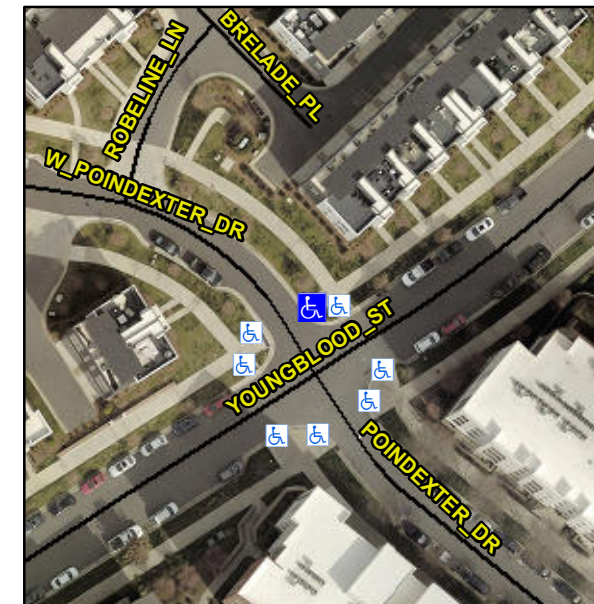
PONDING PREVENTED GTR SLOPES

Compliance	Description	Data	Compliance	Description	Data
N/A	Ramp Length (in)	109.0	N/A	Grade Break?	N/A
Yes	Ramp Width (in)	95.0	N/A	Grade Break Slope (%)	0.0
No	Ramp Slope (%)	9.4	N/A	Grade Break XSlope (%)	0.0
Yes	Ramp XSlope (%)	0.8			
N/A	Flare Type LT	N/A	N/A	Flare Type RT	N/A
N/A	Flare Slope LT (%)	N/A	N/A	Flare Slope RT (%)	0.0
N/A	Flare Traversable LT?	N/A	N/A	Flare Traversable RT?	N/A
N/A	Landing Length (in)	0.0	N/A	DWS Provided?	N/A
N/A	Landing Width (in)	0.0	N/A	DWS Contrast?	N/A
N/A	Landing Slope (%)	0.0	N/A	DWS Length (in)	N/A
N/A	Landing X Slope (%)	0.0	N/A	DWS Full Width?	N/A
N/A	Landing Curb? (Y/N)	N/A	N/A	DWS Offset LT (in)	N/A
N/A	Shared Landing?	N/A	N/A	DWS Offset RT (in)	N/A
N/A	Gutter Ponding?	0.0	N/A	Gutter Slope (%)	N/A
N/A	Gutter Lip Ht (in)	0.0	N/A	Gutter X Slope (%)	N/A
N/A	Painted X Walk1?	No		Road Slope (%)	1.6
	X Walk 1 Direction	To SW		Road X Slope (%)	0.5
	X Walk 1 Width (in)	N/A		Clear Space?	N/A

Remove & Replace Entire Ramp.
