Access Compliance Report
Public Rights-of-Way
(Curb Ramps)

Intersection ID: 11457 **Main Street:** TRYON-CHURCH_CONNECTOR_ST **Cross Street:** N_CHURCH_ST **Location:** E

ADA ID: 6BF752BDA274 **Ramp Type:** Para **Initial Pass/Fail:** Fail **Overall Compliance:** No **Severity Score:** 12.5

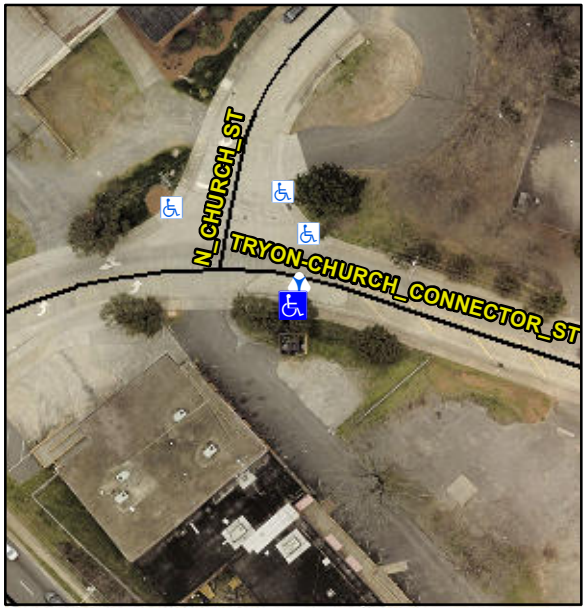
R304.5.3

Compliance	Description	Data	Compliance	Description	Data
N/A	Ramp Length LT (in)	70.0	N/A	Ramp Length RT (in)	70.5
Yes	Ramp Width LT (in)	60.0	Yes	Ramp Width RT (in)	59.5
Yes	Ramp Slope LT (%)	5.0	Yes	Ramp Slope RT (%)	6.8
No	Ramp XSlope LT (%)	2.3	No	Ramp XSlope RT (%)	6.0
N/A	Landing Length (in)	N/A	N/A	DWS Provided?	N/A
N/A	Landing Width (in)	N/A	N/A	DWS Contrast?	N/A
N/A	Landing Slope (%)	N/A	N/A	DWS Length (in)	N/A
N/A	Landing X Slope (%)	N/A	N/A	DWS Full Width?	N/A
N/A	Landing Curb? (Y/N)	N/A	N/A	DWS Offset (in)	N/A
N/A	Shared Landing?	N/A			
N/A	Gutter Ponding?	N/A	N/A	Gutter Slope (%)	N/A
N/A	Gutter Lip Ht (in)	N/A	N/A	Gutter X Slope (%)	N/A
N/A	Painted X Walk1?	No	N/A	Painted X Walk2?	N/A
	X Walk 1 Direction	To N		X Walk 2 Direction	N/A
N/A	X Walk 1 Width (in)	N/A	N/A	X Walk 2 Width (in)	N/A
	X Walk 1 Slope (%)	6.2		X Walk 2 Slope (%)	N/A
	X Walk 1 X Slope (%)	1.3		X Walk 2 X Slope (%)	N/A
N/A	Ramp inside XWalk1?	N/A	N/A	Ramp inside XWalk2?	N/A

Remove & Replace Entire Ramp.
