Access Compliance Report
Public Rights-of-Way
(Curb Ramps)

Intersection ID: 3673	Main Street: KEENELAND_LN	Cross Street: DENALI_LN	Location:	NW
ADA ID: 6C0192D9A6E0	Ramp Type: Perp	Initial Pass/Fail: Fail	Overall Compliance: No	Severity Score: 8.75

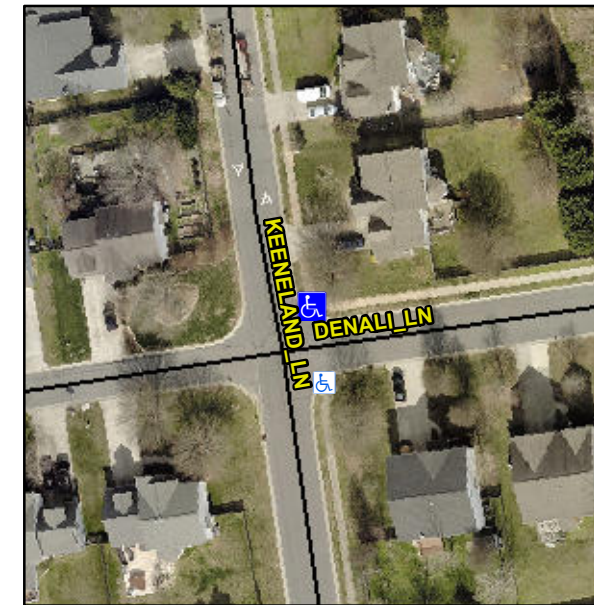
Not Found, R304.5.1

Compliance	Description	Data	Compliance	Description	Data
N/A	Ramp Length (in)	48.0	Yes	Ramp Slope (%)	5.0
No	Ramp Width (in)	47.5	Yes	Ramp XSlope (%)	0.1
N/A	Flare Type LT	N/A	N/A	Flare Type RT	N/A
N/A	Flare Slope LT (%)	N/A	N/A	Flare Slope RT (%)	N/A
N/A	Flare Traversable LT?	N/A	N/A	Flare Traversable RT?	N/A
N/A	Landing Length (in)	N/A	N/A	DWS Provided?	N/A
N/A	Landing Width (in)	N/A	N/A	DWS Contrast?	N/A
N/A	Landing Slope (%)	N/A	N/A	DWS Length (in)	N/A
N/A	Landing X Slope (%)	N/A	N/A	DWS Full Width?	N/A
N/A	Landing Curb? (Y/N)	N/A	N/A	DWS Offset (in)	N/A
N/A	Shared Landing?	N/A			
N/A	Gutter Ponding?	N/A	N/A	Gutter Slope (%)	N/A
N/A	Gutter Lip Ht (in)	N/A	N/A	Gutter X Slope (%)	N/A
N/A	Painted X Walk1?	No	N/A	Painted X Walk2?	N/A
	X Walk 1 Direction	To S		X Walk 2 Direction	N/A
N/A	X Walk 1 Width (in)	N/A	N/A	X Walk 2 Width (in)	N/A
	X Walk 1 Slope (%)	2.3		X Walk 2 Slope (%)	N/A
	X Walk 1 X Slope (%)	4.7		X Walk 2 X Slope (%)	N/A

N/A	Ramp inside XWalk1?	N/A	N/A	Ramp inside XWalk2?	N/A
	Road Slope (%)	N/A	N/A	Clear Space?	N/A
	Road X Slope (%)	N/A	N/A	Clear Space to XWalk (in)	N/A
N/A	Any Obstructions?	N/A	N/A	Storm Grate/Utility Hazard?	N/A
	Obstruction Type			Storm Grate/Utility Type	
N/A					N/A
			Yes	Surface Condition? (G/P)	Good

Remove & Replace Entire Ramp.
