Access Compliance Report
Public Rights-of-Way
(Curb Ramps)

Intersection ID: N/A | **Main Street:** TYVOLA_RD | **Cross Street:** SPEER_BV | **Location:** S

ADA ID: 6C12BC0D5B2A | **Ramp Type:** Perp | **Initial Pass/Fail:** Fail | **Overall Compliance:** No | **Severity Score:** 21.25

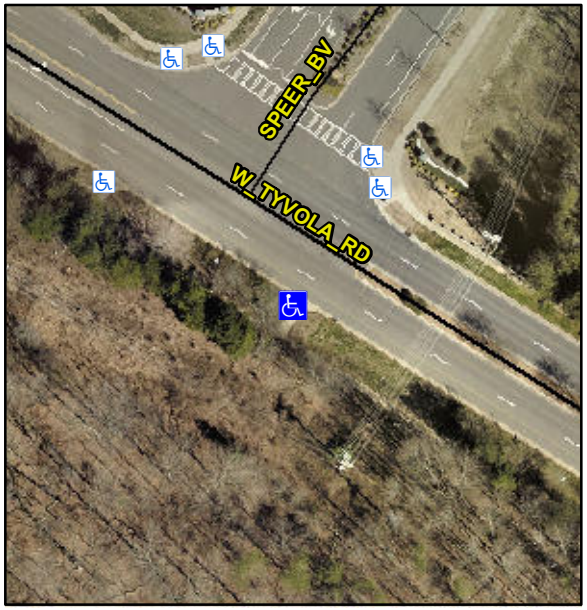
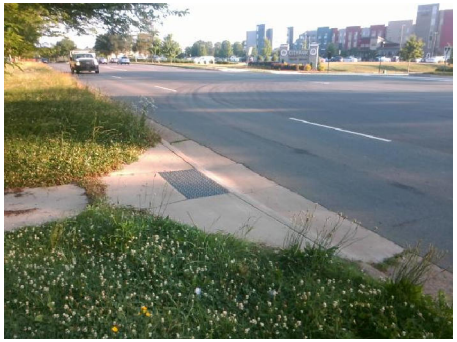
Not Found, R304.5.1, R304.2.2

Compliance	Description	Data	Compliance	Description	Data
N/A	Ramp Length (in)	62.5	No	Ramp Slope (%)	10.0
No	Ramp Width (in)	46.5	Yes	Ramp XSlope (%)	0.8
N/A	Flare Type LT	N/A	N/A	Flare Type RT	N/A
N/A	Flare Slope LT (%)	N/A	N/A	Flare Slope RT (%)	N/A
N/A	Flare Traversable LT?	N/A	N/A	Flare Traversable RT?	N/A
N/A	Landing Length (in)	N/A	N/A	DWS Provided?	N/A
N/A	Landing Width (in)	N/A	N/A	DWS Contrast?	N/A
N/A	Landing Slope (%)	N/A	N/A	DWS Length (in)	N/A
N/A	Landing X Slope (%)	N/A	N/A	DWS Full Width?	N/A
N/A	Landing Curb? (Y/N)	N/A	N/A	DWS Offset (in)	N/A
N/A	Shared Landing?	N/A			
N/A	Gutter Ponding?	N/A	N/A	Gutter Slope (%)	N/A
N/A	Gutter Lip Ht (in)	N/A	N/A	Gutter X Slope (%)	N/A
N/A	Painted X Walk1?	No	N/A	Painted X Walk2?	N/A
	X Walk 1 Direction	To NE		X Walk 2 Direction	N/A
N/A	X Walk 1 Width (in)	N/A	N/A	X Walk 2 Width (in)	N/A
	X Walk 1 Slope (%)	1.8		X Walk 2 Slope (%)	N/A

Remove & Replace Entire Ramp.
