Access Compliance Report
Public Rights-of-Way
(Curb Ramps)

Intersection ID: 54709	**Main Street: MARY_BUTLER_WY**	**Cross Street: OLD_PROVIDENCE_RD**	**Location: SW**
ADA ID: 6CB6EB725D68	**Ramp Type: Perp**	**Initial Pass/Fail: Fail**	**Overall Compliance: No** / **Severity Score: 12.5**

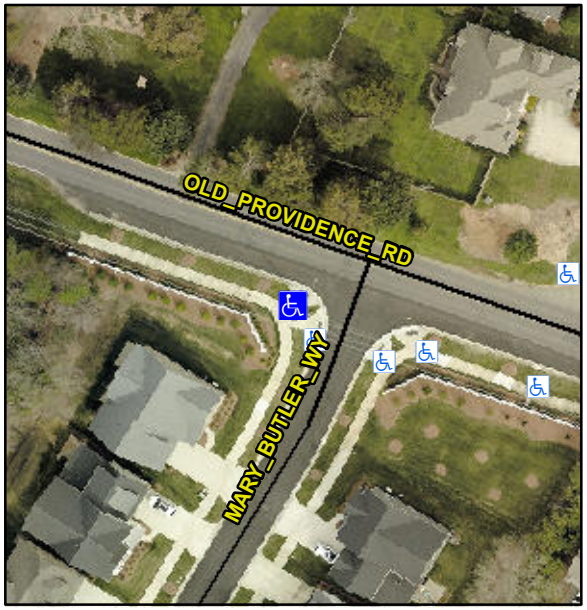
Not Found, R304.5.3

Remove & Replace Entire Ramp.
