Access Compliance Report
Public Rights-of-Way
(Curb Ramps)

Intersection ID: 17009	Main Street: N_WENDOVER_RD	Cross Street: RANDOLPH RD	Location:	W
ADA ID: 6CDD0CDF3312	Ramp Type: Perp	Initial Pass/Fail: Fail	Overall Compliance: No	Severity Score: 33.75

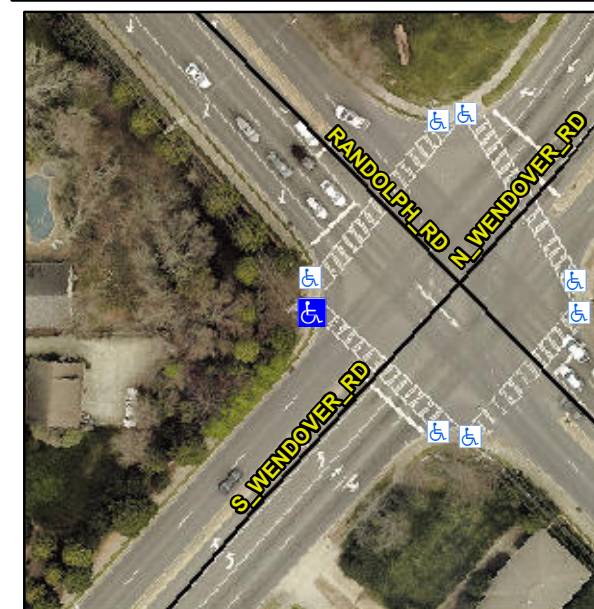
Not Found, R304.5.1, R304.5.3

Compliance	Description	Data	Compliance	Description	Data
N/A	Ramp Length (in)	81.0	Yes	Ramp Slope (%)	6.6
No	Ramp Width (in)	42.0	No	Ramp XSlope (%)	8.5
N/A	Flare Type LT	N/A	N/A	Flare Type RT	N/A
N/A	Flare Slope LT (%)	N/A	N/A	Flare Slope RT (%)	N/A
N/A	Flare Traversable LT?	N/A	N/A	Flare Traversable RT?	N/A
N/A	Landing Length (in)	N/A	N/A	DWS Provided?	N/A
N/A	Landing Width (in)	N/A	N/A	DWS Contrast?	N/A
N/A	Landing Slope (%)	N/A	N/A	DWS Length (in)	N/A
N/A	Landing X Slope (%)	N/A	N/A	DWS Full Width?	N/A
N/A	Landing Curb? (Y/N)	N/A	N/A	DWS Offset (in)	N/A
N/A	Shared Landing?	N/A			
N/A	Gutter Ponding?	N/A	N/A	Gutter Slope (%)	N/A
N/A	Gutter Lip Ht (in)	N/A	N/A	Gutter X Slope (%)	N/A
N/A	Painted X Walk1?	Yes	N/A	Painted X Walk2?	N/A
	X Walk 1 Direction	To SE		X Walk 2 Direction	N/A
N/A	X Walk 1 Width (in)	87.0	N/A	X Walk 2 Width (in)	N/A
	X Walk 1 Slope (%)	6.3		X Walk 2 Slope (%)	N/A
	X Walk 1 X Slope (%)	1.5		X Walk 2 X Slope (%)	N/A

N/A	Ramp inside XWalk1?	Yes	N/A	Ramp inside XWalk2?	N/A
	Road Slope (%)	N/A	N/A	Clear Space?	N/A
	Road X Slope (%)	N/A	N/A	Clear Space to XWalk (in)	N/A
N/A	Any Obstructions?	N/A	N/A	Storm Grate/Utility Hazard?	N/A
	Obstruction Type			Storm Grate/Utility Type	
N/A					N/A
			Yes	Surface Condition? (G/P)	Good

Remove & Replace Entire Ramp.
