Access Compliance Report
Public Rights-of-Way
(Curb Ramps)

Intersection ID: 3548	**Main Street: ARDEN_GATE_LN**	**Cross Street: TAVERNAY_PY**	**Location:**	**W**
ADA ID: 6D04F1D8AAB4	**Ramp Type: Perp**	**Initial Pass/Fail: Fail**	**Overall Compliance: No**	**Severity Score: 12.5**

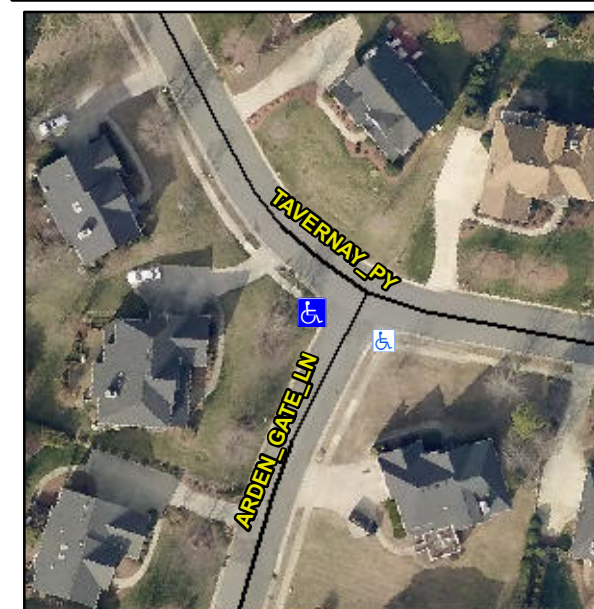
Not Found, R304.5.3

Compliance	Description	Data	Compliance	Description	Data
N/A	Ramp Length (in)	48.0	Yes	Ramp Slope (%)	5.1
Yes	Ramp Width (in)	48.0	No	Ramp XSlope (%)	6.4
N/A	Flare Type LT	N/A	N/A	Flare Type RT	N/A
N/A	Flare Slope LT (%)	N/A	N/A	Flare Slope RT (%)	N/A
N/A	Flare Traversable LT?	N/A	N/A	Flare Traversable RT?	N/A
N/A	Landing Length (in)	N/A	N/A	DWS Provided?	N/A
N/A	Landing Width (in)	N/A	N/A	DWS Contrast?	N/A
N/A	Landing Slope (%)	N/A	N/A	DWS Length (in)	N/A
N/A	Landing X Slope (%)	N/A	N/A	DWS Full Width?	N/A
N/A	Landing Curb? (Y/N)	N/A	N/A	DWS Offset (in)	N/A
N/A	Shared Landing?	N/A			
N/A	Gutter Ponding?	N/A	N/A	Gutter Slope (%)	N/A
N/A	Gutter Lip Ht (in)	N/A	N/A	Gutter X Slope (%)	N/A
N/A	Painted X Walk1?	No	N/A	Painted X Walk2?	N/A
	X Walk 1 Direction	To SE		X Walk 2 Direction	N/A
N/A	X Walk 1 Width (in)	N/A	N/A	X Walk 2 Width (in)	N/A
	X Walk 1 Slope (%)	1.8		X Walk 2 Slope (%)	N/A
	X Walk 1 X Slope (%)	4.2		X Walk 2 X Slope (%)	N/A

Remove & Replace Entire Ramp.
