Access Compliance Report
Public Rights-of-Way
(Curb Ramps)

Intersection ID: N/A	Main Street: AGNEW_DR	Cross Street: PAMPLIN_CT	Location:	NW

ADA ID: 6DA83F22B21C	Ramp Type: Perp	Initial Pass/Fail: Fail	Overall Compliance: No	Severity Score: 10

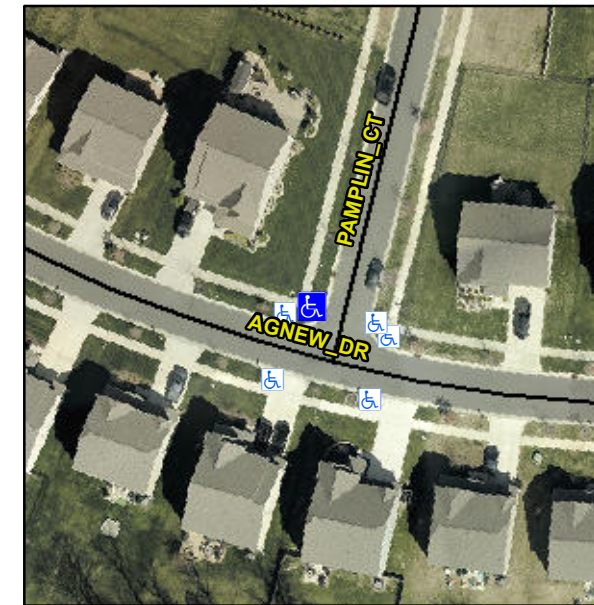
Not Found, R304.5.1, R304.5.3

Compliance	Description	Data	Compliance	Description	Data
N/A	Ramp Length (in)	102.0	Yes	Ramp Slope (%)	6.6
No	Ramp Width (in)	47.0	No	Ramp XSlope (%)	2.2
N/A	Flare Type LT	N/A	N/A	Flare Type RT	N/A
N/A	Flare Slope LT (%)	N/A	N/A	Flare Slope RT (%)	N/A
N/A	Flare Traversable LT?	N/A	N/A	Flare Traversable RT?	N/A
N/A	Landing Length (in)	N/A	N/A	DWS Provided?	N/A
N/A	Landing Width (in)	N/A	N/A	DWS Contrast?	N/A
N/A	Landing Slope (%)	N/A	N/A	DWS Length (in)	N/A
N/A	Landing X Slope (%)	N/A	N/A	DWS Full Width?	N/A
N/A	Landing Curb? (Y/N)	N/A	N/A	DWS Offset (in)	N/A
N/A	Shared Landing?	N/A			
N/A	Gutter Ponding?	N/A	N/A	Gutter Slope (%)	N/A
N/A	Gutter Lip Ht (in)	N/A	N/A	Gutter X Slope (%)	N/A
N/A	Painted X Walk1?	No	N/A	Painted X Walk2?	N/A
	X Walk 1 Direction	To SE		X Walk 2 Direction	N/A
N/A	X Walk 1 Width (in)	N/A	N/A	X Walk 2 Width (in)	N/A
	X Walk 1 Slope (%)	2.6		X Walk 2 Slope (%)	N/A
	X Walk 1 X Slope (%)	2.4		X Walk 2 X Slope (%)	N/A

Remove & Replace Entire Ramp.
