Access Compliance Report
Public Rights-of-Way
(Curb Ramps)

Intersection ID: 54413	Main Street: ARDREY_KELL_RD	Cross Street: LISMORE_LN	Location:	S
ADA ID: 6DB8A64BB1C1	Ramp Type: Perp	Initial Pass/Fail: Fail	Overall Compliance: No	Severity Score: 1.25

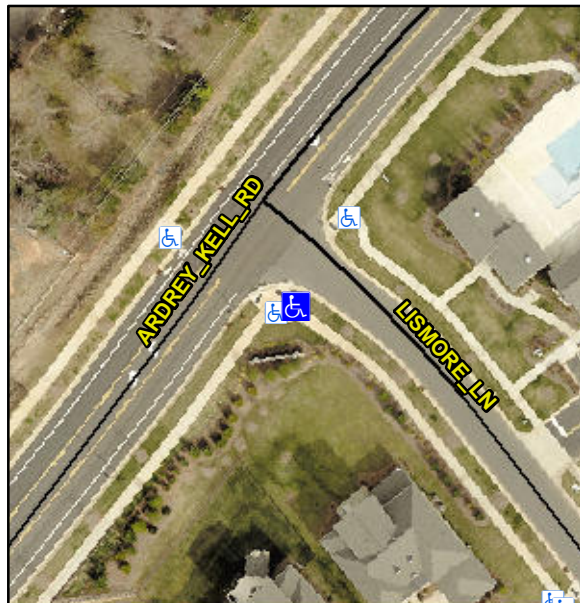
Not Found, R304.5.3

Compliance	Description	Data	Compliance	Description	Data
N/A	Ramp Length (in)	97.0	Yes	Ramp Slope (%)	7.2
Yes	Ramp Width (in)	60.0	No	Ramp XSlope (%)	4.0
N/A	Flare Type LT	N/A	N/A	Flare Type RT	N/A
N/A	Flare Slope LT (%)	N/A	N/A	Flare Slope RT (%)	N/A
N/A	Flare Traversable LT?	N/A	N/A	Flare Traversable RT?	N/A
N/A	Landing Length (in)	N/A	N/A	DWS Provided?	N/A
N/A	Landing Width (in)	N/A	N/A	DWS Contrast?	N/A
N/A	Landing Slope (%)	N/A	N/A	DWS Length (in)	N/A
N/A	Landing X Slope (%)	N/A	N/A	DWS Full Width?	N/A
N/A	Landing Curb? (Y/N)	N/A	N/A	DWS Offset (in)	N/A
N/A	Shared Landing?	N/A			
N/A	Gutter Ponding?	N/A	N/A	Gutter Slope (%)	N/A
N/A	Gutter Lip Ht (in)	2.0	N/A	Gutter X Slope (%)	N/A
N/A	Painted X Walk1?	No	N/A	Painted X Walk2?	N/A
	X Walk 1 Direction	To NE		X Walk 2 Direction	N/A
N/A	X Walk 1 Width (in)	N/A	N/A	X Walk 2 Width (in)	N/A
	X Walk 1 Slope (%)	1.2		X Walk 2 Slope (%)	N/A
	X Walk 1 X Slope (%)	3.0		X Walk 2 X Slope (%)	N/A

Remove & Replace Entire Ramp.
