# Access Compliance Report
Public Rights-of-Way
(Curb Ramps)

Intersection ID: 50272	Main Street: SOUTH_BV	Cross Street: WHITTON_ST	Location:	SE
ADA ID: 6E34F8836E4D	Ramp Type: Perp	Initial Pass/Fail: Fail	Overall Compliance: No	Severity Score: 12.5

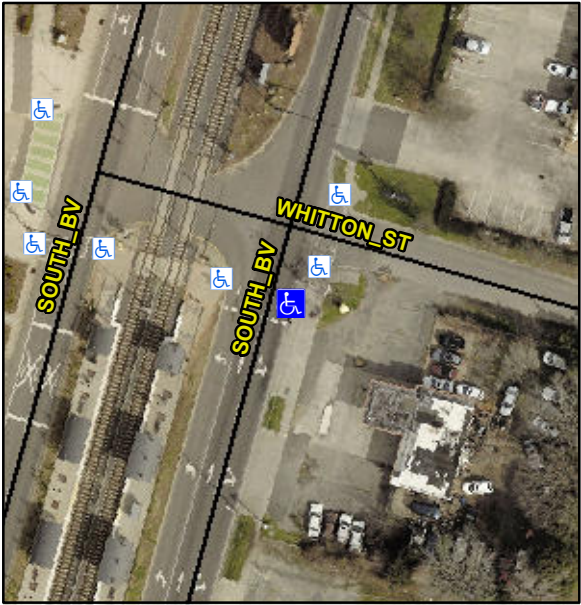
Not Found, R304.5.3

Compliance	Description	Data	Compliance	Description	Data
N/A	Ramp Length (in)	90.0	Yes	Ramp Slope (%)	5.4
Yes	Ramp Width (in)	48.0	No	Ramp XSlope (%)	5.9
N/A	Flare Type LT	N/A	N/A	Flare Type RT	N/A
N/A	Flare Slope LT (%)	N/A	N/A	Flare Slope RT (%)	N/A
N/A	Flare Traversable LT?	N/A	N/A	Flare Traversable RT?	N/A
N/A	Landing Length (in)	N/A	N/A	DWS Provided?	N/A
N/A	Landing Width (in)	N/A	N/A	DWS Contrast?	N/A
N/A	Landing Slope (%)	N/A	N/A	DWS Length (in)	N/A
N/A	Landing X Slope (%)	N/A	N/A	DWS Full Width?	N/A
N/A	Landing Curb? (Y/N)	N/A	N/A	DWS Offset (in)	N/A
N/A	Shared Landing?	N/A			
N/A	Gutter Ponding?	N/A	N/A	Gutter Slope (%)	N/A
N/A	Gutter Lip Ht (in)	N/A	N/A	Gutter X Slope (%)	N/A
N/A	Painted X Walk1?	Yes	N/A	Painted X Walk2?	N/A
	X Walk 1 Direction	To NW		X Walk 2 Direction	N/A
N/A	X Walk 1 Width (in)	118.0	N/A	X Walk 2 Width (in)	N/A
	X Walk 1 Slope (%)	1.4		X Walk 2 Slope (%)	N/A
	X Walk 1 X Slope (%)	0.7		X Walk 2 X Slope (%)	N/A

Remove & Replace Entire Ramp.
