Access Compliance Report
Public Rights-of-Way
(Curb Ramps)

Intersection ID: 20377	Main Street: MORVEN_LN	Cross Street: WINGRAVE_DR	Location: N
ADA ID: 6E6306AF232D	Ramp Type: PerpDiag	Initial Pass/Fail: Fail	Overall Compliance: No Severity Score: 21.25

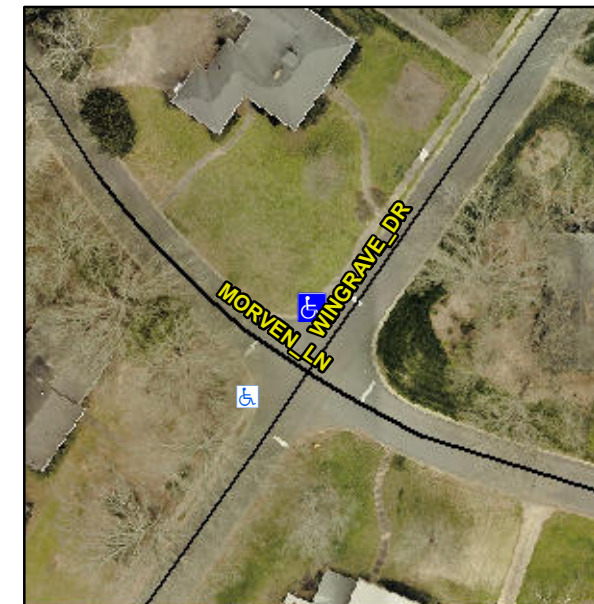
Not Found, R304.5.1, R304.5.3

Compliance	Description	Data	Compliance	Description	Data
N/A	Ramp Length (in)	55.0	Yes	Ramp Slope (%)	7.4
No	Ramp Width (in)	47.5	No	Ramp XSlope (%)	5.3
N/A	Flare Type LT	N/A	N/A	Flare Type RT	N/A
N/A	Flare Slope LT (%)	N/A	N/A	Flare Slope RT (%)	N/A
N/A	Flare Traversable LT?	N/A	N/A	Flare Traversable RT?	N/A
N/A	Landing Length (in)	N/A	N/A	DWS Provided?	N/A
N/A	Landing Width (in)	N/A	N/A	DWS Contrast?	N/A
N/A	Landing Slope (%)	N/A	N/A	DWS Length (in)	N/A
N/A	Landing X Slope (%)	N/A	N/A	DWS Full Width?	N/A
N/A	Landing Curb? (Y/N)	N/A	N/A	DWS Offset (in)	N/A
N/A	Shared Landing?	N/A			
N/A	Gutter Ponding?	N/A	N/A	Gutter Slope (%)	N/A
N/A	Gutter Lip Ht (in)	N/A	N/A	Gutter X Slope (%)	N/A
N/A	Painted X Walk1?	No	N/A	Painted X Walk2?	No
	X Walk 1 Direction	To SW		X Walk 2 Direction	To SE
N/A	X Walk 1 Width (in)	N/A	N/A	X Walk 2 Width (in)	N/A
	X Walk 1 Slope (%)	4.3		X Walk 2 Slope (%)	1.1
	X Walk 1 X Slope (%)	2.6		X Walk 2 X Slope (%)	3.6

Remove & Replace Curb Ramp With Two New Directional Ramps or Equivalent.
