Access Compliance Report

## Public Rights-of-Way
(Curb Ramps)

Intersection ID: 9440	**Main Street:** BRADFORD_DR	**Cross Street:** EDGEWOOD_RD	**Location:** SW
ADA ID: 70479C7DEB62	**Ramp Type:** Perp	**Initial Pass/Fail:** Fail	**Overall Compliance:** No	**Severity Score:** 12.5

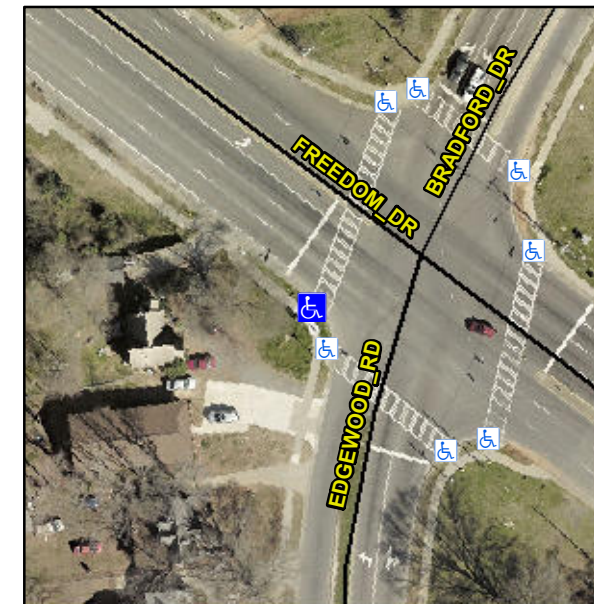
Not Found, R304.2.2

Compliance	Description	Data	Compliance	Description	Data
N/A	Ramp Length (in)	60.0	No	Ramp Slope (%)	9.8
Yes	Ramp Width (in)	48.0	Yes	Ramp XSlope (%)	0.6
N/A	Flare Type LT	N/A	N/A	Flare Type RT	N/A
N/A	Flare Slope LT (%)	N/A	N/A	Flare Slope RT (%)	N/A
N/A	Flare Traversable LT?	N/A	N/A	Flare Traversable RT?	N/A
N/A	Landing Length (in)	N/A	N/A	DWS Provided?	N/A
N/A	Landing Width (in)	N/A	N/A	DWS Contrast?	N/A
N/A	Landing Slope (%)	N/A	N/A	DWS Length (in)	N/A
N/A	Landing X Slope (%)	N/A	N/A	DWS Full Width?	N/A
N/A	Landing Curb? (Y/N)	N/A	N/A	DWS Offset (in)	N/A
N/A	Shared Landing?	N/A			
N/A	Gutter Ponding?	N/A	N/A	Gutter Slope (%)	N/A
N/A	Gutter Lip Ht (in)	N/A	N/A	Gutter X Slope (%)	N/A
N/A	Painted X Walk1?	Yes	N/A	Painted X Walk2?	N/A
	X Walk 1 Direction	To N		X Walk 2 Direction	N/A
N/A	X Walk 1 Width (in)	116.0	N/A	X Walk 2 Width (in)	N/A
	X Walk 1 Slope (%)	0.6		X Walk 2 Slope (%)	N/A
	X Walk 1 X Slope (%)	2.5		X Walk 2 X Slope (%)	N/A

Remove & Replace Entire Ramp.
