Access Compliance Report
Public Rights-of-Way
(Curb Ramps)

Intersection ID: 52526	**Main Street: MCCLINTOCK_RD**	**Cross Street: ANDREWS_LN**	**Location: SE**
ADA ID: 7054FF016715	**Ramp Type: Perp**	**Initial Pass/Fail: Fail** **Overall Compliance: No**	**Severity Score: 10**

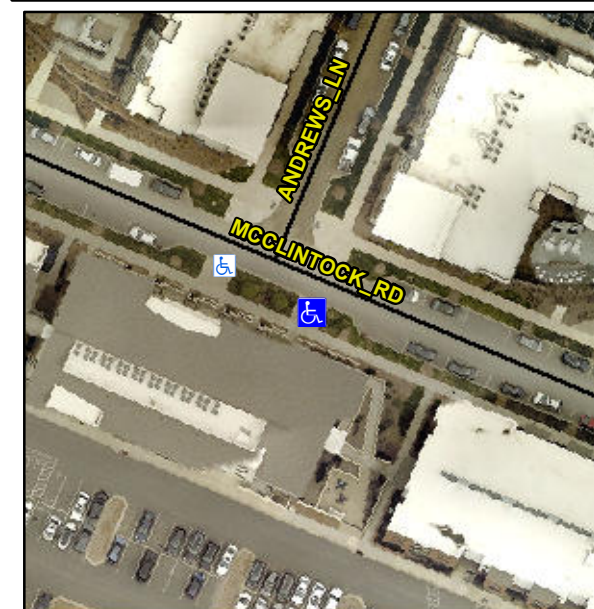
R304.5.1

Compliance	Description	Data	Compliance	Description	Data
N/A	Ramp Length (in)	78.0	Yes	Ramp Slope (%)	6.5
No	Ramp Width (in)	47.5	Yes	Ramp XSlope (%)	3.5
N/A	Flare Type LT	N/A	N/A	Flare Type RT	N/A
N/A	Flare Slope LT (%)	N/A	N/A	Flare Slope RT (%)	N/A
N/A	Flare Traversable LT?	N/A	N/A	Flare Traversable RT?	N/A
N/A	Landing Length (in)	N/A	N/A	DWS Provided?	N/A
N/A	Landing Width (in)	N/A	N/A	DWS Contrast?	N/A
N/A	Landing Slope (%)	N/A	N/A	DWS Length (in)	N/A
N/A	Landing X Slope (%)	N/A	N/A	DWS Full Width?	N/A
N/A	Landing Curb? (Y/N)	N/A	N/A	DWS Offset (in)	N/A
N/A	Shared Landing?	N/A			
N/A	Gutter Ponding?	N/A	N/A	Gutter Slope (%)	N/A
N/A	Gutter Lip Ht (in)	N/A	N/A	Gutter X Slope (%)	N/A
N/A	Painted X Walk1?	No	N/A	Painted X Walk2?	N/A
	X Walk 1 Direction	To NE		X Walk 2 Direction	N/A
N/A	X Walk 1 Width (in)	N/A	N/A	X Walk 2 Width (in)	N/A
	X Walk 1 Slope (%)	2.1		X Walk 2 Slope (%)	N/A
	X Walk 1 X Slope (%)	4.2		X Walk 2 X Slope (%)	N/A

Remove & Replace Entire Ramp.
