Access Compliance Report
Public Rights-of-Way
(Curb Ramps)

Intersection ID: 50302	Main Street: PINE_CHAPEL_DR	Cross Street: PINE_TERRACE_CT	Location:	E
ADA ID: 70934003F6F7	Ramp Type: PerpDiag	Initial Pass/Fail: Fail	Overall Compliance: No	Severity Score: 10

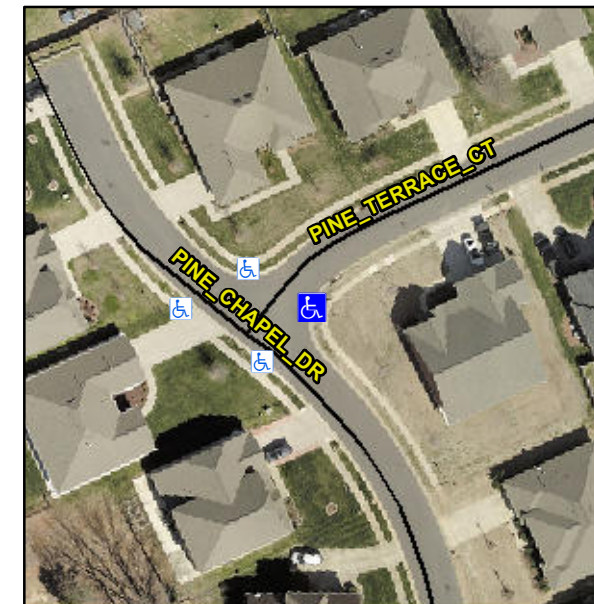
R304.5.1, R304.5.3

Compliance	Description	Data	Compliance	Description	Data
N/A	Ramp Length (in)	49.0	Yes	Ramp Slope (%)	5.4
No	Ramp Width (in)	47.0	No	Ramp XSlope (%)	3.0
N/A	Flare Type LT	N/A	N/A	Flare Type RT	N/A
N/A	Flare Slope LT (%)	N/A	N/A	Flare Slope RT (%)	N/A
N/A	Flare Traversable LT?	N/A	N/A	Flare Traversable RT?	N/A
N/A	Landing Length (in)	N/A	N/A	DWS Provided?	N/A
N/A	Landing Width (in)	N/A	N/A	DWS Contrast?	N/A
N/A	Landing Slope (%)	N/A	N/A	DWS Length (in)	N/A
N/A	Landing X Slope (%)	N/A	N/A	DWS Full Width?	N/A
N/A	Landing Curb? (Y/N)	N/A	N/A	DWS Offset (in)	N/A
N/A	Shared Landing?	N/A			
N/A	Gutter Ponding?	N/A	N/A	Gutter Slope (%)	N/A
N/A	Gutter Lip Ht (in)	N/A	N/A	Gutter X Slope (%)	N/A
N/A	Painted X Walk1?	No	N/A	Painted X Walk2?	No
	X Walk 1 Direction	To NW		X Walk 2 Direction	To SW
N/A	X Walk 1 Width (in)	N/A	N/A	X Walk 2 Width (in)	N/A
	X Walk 1 Slope (%)	0.8		X Walk 2 Slope (%)	1.3
	X Walk 1 X Slope (%)	0.6		X Walk 2 X Slope (%)	2.1

Remove & Replace Curb Ramp With Two New Directional Ramps or Equivalent.
