# Access Compliance Report
Public Rights-of-Way
(Curb Ramps)

Intersection ID: 54217	Main Street: GOLF_LINKS_DR	Cross Street: MIDWAY_PARK_DR	Location:	SW
ADA ID: 71406C51C051	Ramp Type: Perp	Initial Pass/Fail: Pass	Overall Compliance: No	Severity Score: 0.25

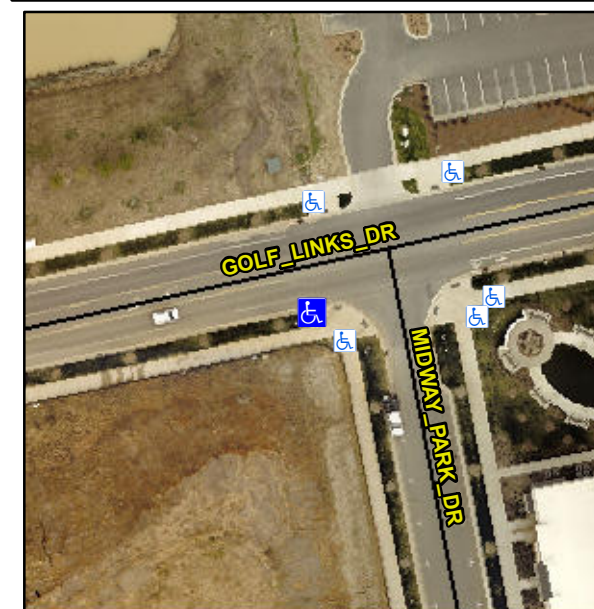
R304.5.3, R305.2

Compliance	Description	Data	Compliance	Description	Data
N/A	Ramp Length (in)	105.0	Yes	Ramp Slope (%)	5.9
Yes	Ramp Width (in)	52.0	No	Ramp XSlope (%)	2.2
N/A	Flare Type LT	Sloped	N/A	Flare Type RT	N/A
N/A	Flare Slope LT (%)	4.1	Yes	Flare Slope RT (%)	5.3
N/A	Flare Traversable LT?	Yes	N/A	Flare Traversable RT?	Yes
Yes	Landing Length (in)	93.0	Yes	DWS Provided?	Yes
Yes	Landing Width (in)	52.0	Yes	DWS Contrast?	Yes
Yes	Landing Slope (%)	0.5	Yes	DWS Length (in)	24.0
No	Landing X Slope (%)	2.6	Yes	DWS Full Width?	Yes
N/A	Landing Curb? (Y/N)	No	No	DWS Offset (in)	4.5
N/A	Shared Landing?	No			
Yes	Gutter Ponding?	No	Yes	Gutter Slope (%)	4.4
Yes	Gutter Lip Ht (in)	0.0	Yes	Gutter X Slope (%)	1.1
N/A	Painted X Walk1?	No	N/A	Painted X Walk2?	N/A
	X Walk 1 Direction	To N		X Walk 2 Direction	N/A
N/A	X Walk 1 Width (in)	N/A	N/A	X Walk 2 Width (in)	N/A
	X Walk 1 Slope (%)	5.4		X Walk 2 Slope (%)	N/A
	X Walk 1 X Slope (%)	0.4		X Walk 2 X Slope (%)	N/A

N/A	Ramp inside XWalk1?	N/A	N/A	Ramp inside XWalk2?	N/A
	Road Slope (%)	N/A	N/A	Clear Space?	Yes
	Road X Slope (%)	N/A	N/A	Clear Space to XWalk (in)	N/A
Yes	Any Obstructions?	No	Yes	Storm Grate/Utility Hazard?	No
	Obstruction Type			Storm Grate/Utility Type	
			N/A		N/A
			Yes	Surface Condition? (G/P)	Good

Remove & Replace Entire Ramp.
