Access Compliance Report
Public Rights-of-Way
(Curb Ramps)

Intersection ID: 13740	Main Street: CENTRAL_AV	Cross Street: LONGFELLOW_ST	Location:	NW
ADA ID: 7197A70442C1	Ramp Type: Perp	Initial Pass/Fail: Fail	Overall Compliance: No	Severity Score: 10

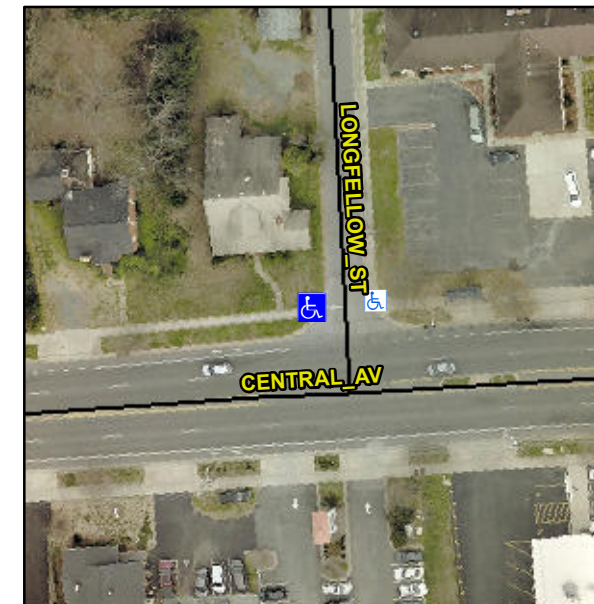
Not Found, R304.5.1, R304.5.3

Compliance	Description	Data	Compliance	Description	Data
N/A	Ramp Length (in)	86.0	Yes	Ramp Slope (%)	5.4
No	Ramp Width (in)	38.0	No	Ramp XSlope (%)	2.2
N/A	Flare Type LT	N/A	N/A	Flare Type RT	N/A
N/A	Flare Slope LT (%)	N/A	N/A	Flare Slope RT (%)	N/A
N/A	Flare Traversable LT?	N/A	N/A	Flare Traversable RT?	N/A
N/A	Landing Length (in)	N/A	N/A	DWS Provided?	N/A
N/A	Landing Width (in)	N/A	N/A	DWS Contrast?	N/A
N/A	Landing Slope (%)	N/A	N/A	DWS Length (in)	N/A
N/A	Landing X Slope (%)	N/A	N/A	DWS Full Width?	N/A
N/A	Landing Curb? (Y/N)	N/A	N/A	DWS Offset (in)	N/A
N/A	Shared Landing?	N/A			
N/A	Gutter Ponding?	N/A	N/A	Gutter Slope (%)	N/A
N/A	Gutter Lip Ht (in)	N/A	N/A	Gutter X Slope (%)	N/A
N/A	Painted X Walk1?	No	N/A	Painted X Walk2?	N/A
	X Walk 1 Direction	To E		X Walk 2 Direction	N/A
N/A	X Walk 1 Width (in)	N/A	N/A	X Walk 2 Width (in)	N/A
	X Walk 1 Slope (%)	2.1		X Walk 2 Slope (%)	N/A
	X Walk 1 X Slope (%)	0.2		X Walk 2 X Slope (%)	N/A

Remove & Replace Entire Ramp.
