# Access Compliance Report
# Public Rights-of-Way
# (Curb Ramps)

| **Intersection ID: 30206** | **Main Street: COY_CT** | **Cross Street: PATRICIA_RYAN_DR** | **Location: W** |
| **ADA ID: 719FACD48B97** | **Ramp Type: Perp** | **Initial Pass/Fail: Fail Overall Compliance: No** | **Severity Score: 8.75** |

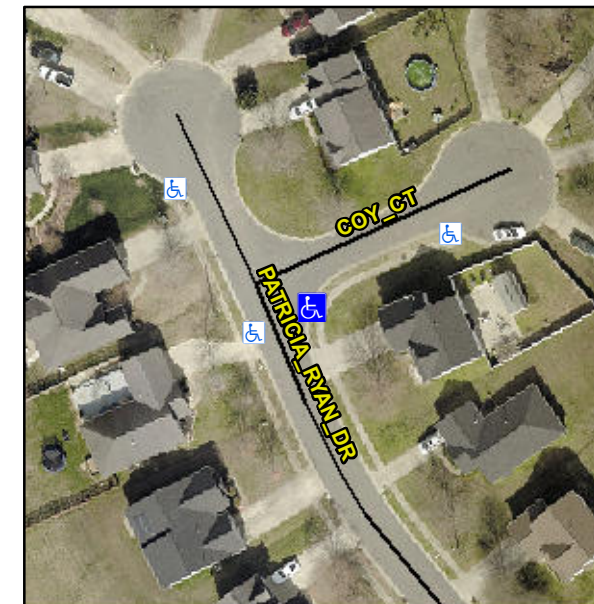
**R304.5.1**

| Compliance | Description | Data | Compliance | Description | Data |
|---|---|---|---|---|---|
| No | Ramp Width (in) | 45.0 | Yes | Ramp XSlope (%) | 1.9 |

**Remove & Replace Entire Ramp.**
