Access Compliance Report
Public Rights-of-Way
(Curb Ramps)

Intersection ID: 15489	Main Street: HARVARD_PL	Cross Street: QUEENS_RD	Location:	E
ADA ID: 71BF1DCFE31C	Ramp Type: Perp	Initial Pass/Fail: Fail	Overall Compliance: No	Severity Score: 72.5

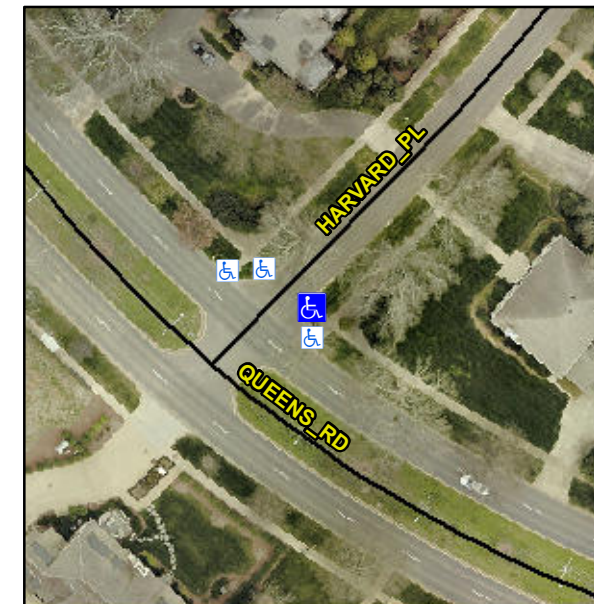
Not Found, R304.5.1, R304.2.2, R304.5.3

Compliance	Description	Data	Compliance	Description	Data
N/A	Ramp Length (in)	57.0	No	Ramp Slope (%)	11.0
No	Ramp Width (in)	28.0	No	Ramp XSlope (%)	8.1
N/A	Flare Type LT	N/A	N/A	Flare Type RT	N/A
N/A	Flare Slope LT (%)	N/A	N/A	Flare Slope RT (%)	N/A
N/A	Flare Traversable LT?	N/A	N/A	Flare Traversable RT?	N/A
N/A	Landing Length (in)	N/A	N/A	DWS Provided?	N/A
N/A	Landing Width (in)	N/A	N/A	DWS Contrast?	N/A
N/A	Landing Slope (%)	N/A	N/A	DWS Length (in)	N/A
N/A	Landing X Slope (%)	N/A	N/A	DWS Full Width?	N/A
N/A	Landing Curb? (Y/N)	N/A	N/A	DWS Offset (in)	N/A
N/A	Shared Landing?	N/A			
N/A	Gutter Ponding?	N/A	N/A	Gutter Slope (%)	N/A
N/A	Gutter Lip Ht (in)	N/A	N/A	Gutter X Slope (%)	N/A
N/A	Painted X Walk1?	No	N/A	Painted X Walk2?	N/A
	X Walk 1 Direction	To NW		X Walk 2 Direction	N/A
N/A	X Walk 1 Width (in)	N/A	N/A	X Walk 2 Width (in)	N/A
	X Walk 1 Slope (%)	3.6		X Walk 2 Slope (%)	N/A
	X Walk 1 X Slope (%)	0.9		X Walk 2 X Slope (%)	N/A

Remove & Replace Entire Ramp.
