# Access Compliance Report
Public Rights-of-Way
(Curb Ramps)

Intersection ID: 10012468	Main Street: IBM_DR	Cross Street: IBM_DR	Location:	SE
ADA ID: 71DCB19489D8	Ramp Type: Perp	Initial Pass/Fail: Pass	Overall Compliance: No	Severity Score: 20.25

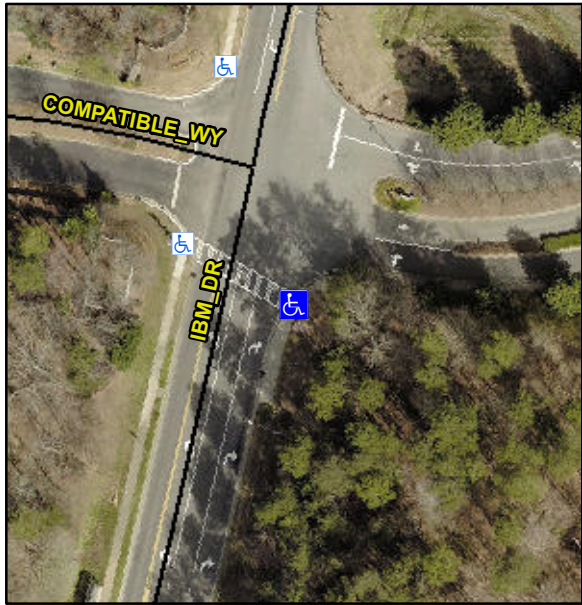
**Not Found, R304.5.3, R304.2.1,
R304.2.2-Perp, R304.3.2-Para,
R304.2.3, R305.2, R304.5.4**

Compliance	Description	Data	Compliance	Description	Data
N/A	Ramp Length (in)	61.0	Yes	Ramp Slope (%)	5.3
Yes	Ramp Width (in)	48.0	No	Ramp XSlope (%)	4.2
N/A	Flare Type LT	Sloped	N/A	Flare Type RT	N/A
N/A	Flare Slope LT (%)	5.0	No	Flare Slope RT (%)	12.8
N/A	Flare Traversable LT?	Yes	N/A	Flare Traversable RT?	Yes
No	Landing Length (in)	N/A	Yes	DWS Provided?	Yes
No	Landing Width (in)	N/A	Yes	DWS Contrast?	Yes
No	Landing Slope (%)	N/A	Yes	DWS Length (in)	24.0
No	Landing X Slope (%)	N/A	Yes	DWS Full Width?	Yes
N/A	Landing Curb? (Y/N)	No	No	DWS Offset (in)	3.5
N/A	Shared Landing?	No			
Yes	Gutter Ponding?	No	No	Gutter Slope (%)	5.1
Yes	Gutter Lip Ht (in)	0.0	No	Gutter X Slope (%)	3.9
N/A	Painted X Walk1?	Yes	N/A	Painted X Walk2?	N/A
	X Walk 1 Direction	To NW		X Walk 2 Direction	N/A
N/A	X Walk 1 Width (in)	111.0	N/A	X Walk 2 Width (in)	N/A
	X Walk 1 Slope (%)	3.1		X Walk 2 Slope (%)	N/A
	X Walk 1 X Slope (%)	3.3		X Walk 2 X Slope (%)	N/A

Yes	Ramp inside XWalk1?	Yes	N/A	Ramp inside XWalk2?	N/A
	Road Slope (%)	N/A	N/A	Clear Space?	Yes
	Road X Slope (%)	N/A	N/A	Clear Space to XWalk (in)	N/A
Yes	Any Obstructions?	No	Yes	Storm Grate/Utility Hazard?	No
	Obstruction Type			Storm Grate/Utility Type	
	N/A				N/A
			Yes	Surface Condition? (G/P)	Good

**Remove & Replace Entire Ramp.
Remove & Replace Gutter.**
