Access Compliance Report
Public Rights-of-Way
(Curb Ramps)

Intersection ID: 10028124 **Main Street:** HAWFIELD_WAY_DR **Cross Street:** N/A **Location:** N

ADA ID: 722F8D28AAE3 **Ramp Type:** Perp **Initial Pass/Fail:** Fail **Overall Compliance:** No **Severity Score:** 21.25

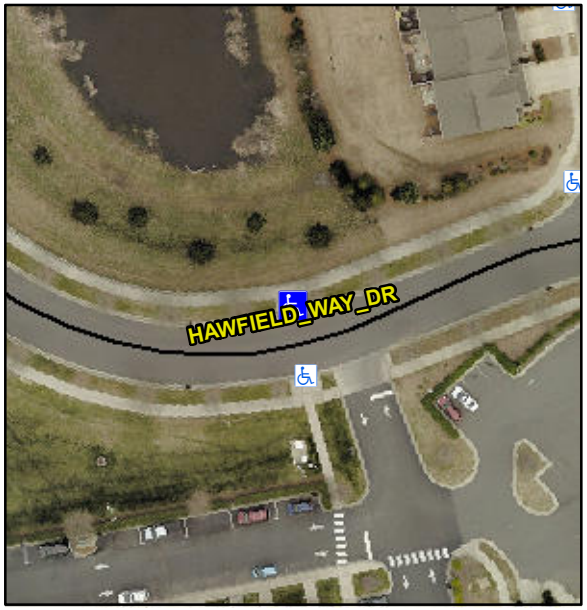
R304.5.1, R304.2.2

Compliance	Description	Data	Compliance	Description	Data
N/A	Ramp Length (in)	97.5	No	Ramp Slope (%)	8.9
No	Ramp Width (in)	47.5	Yes	Ramp XSlope (%)	1.8
N/A	Flare Type LT	N/A	N/A	Flare Type RT	N/A
N/A	Flare Slope LT (%)	N/A	N/A	Flare Slope RT (%)	N/A
N/A	Flare Traversable LT?	N/A	N/A	Flare Traversable RT?	N/A
N/A	Landing Length (in)	N/A	N/A	DWS Provided?	N/A
N/A	Landing Width (in)	N/A	N/A	DWS Contrast?	N/A
N/A	Landing Slope (%)	N/A	N/A	DWS Length (in)	N/A
N/A	Landing X Slope (%)	N/A	N/A	DWS Full Width?	N/A
N/A	Landing Curb? (Y/N)	N/A	N/A	DWS Offset (in)	N/A
N/A	Shared Landing?	N/A			
N/A	Gutter Ponding?	N/A	N/A	Gutter Slope (%)	N/A
N/A	Gutter Lip Ht (in)	N/A	N/A	Gutter X Slope (%)	N/A
N/A	Painted X Walk1?	No	N/A	Painted X Walk2?	N/A
	X Walk 1 Direction	To S		X Walk 2 Direction	N/A
N/A	X Walk 1 Width (in)	N/A	N/A	X Walk 2 Width (in)	N/A
	X Walk 1 Slope (%)	4.1		X Walk 2 Slope (%)	N/A
	X Walk 1 X Slope (%)	1.0		X Walk 2 X Slope (%)	N/A

Remove & Replace Entire Ramp.
