# Access Compliance Report
Public Rights-of-Way
(Curb Ramps)

Intersection ID: 14820	Main Street: BLYTHE_BV	Cross Street: SCOTT_AV	Location:	SE
ADA ID: 736545CA2FD2	Ramp Type: PerpDiag	Initial Pass/Fail: Fail	Overall Compliance: No	Severity Score: 50

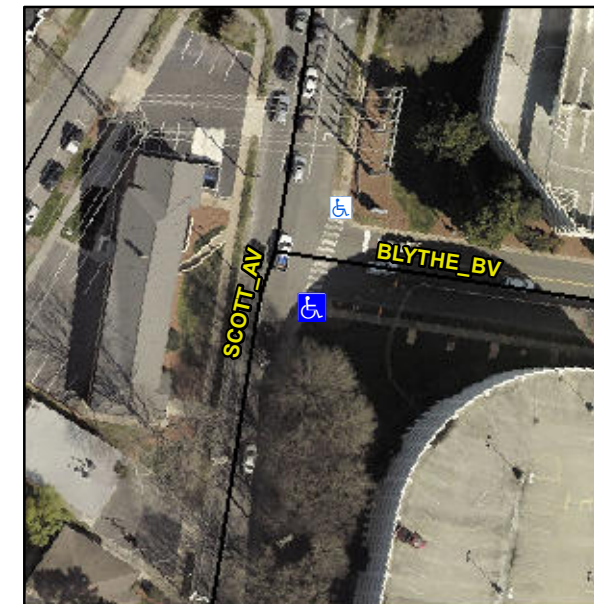
Not Found, R304.2.2, R304.5.3

Compliance	Description	Data	Compliance	Description	Data
N/A	Ramp Length (in)	85.0	No	Ramp Slope (%)	14.1
Yes	Ramp Width (in)	48.0	No	Ramp XSlope (%)	7.6
N/A	Flare Type LT	N/A	N/A	Flare Type RT	N/A
N/A	Flare Slope LT (%)	N/A	N/A	Flare Slope RT (%)	N/A
N/A	Flare Traversable LT?	N/A	N/A	Flare Traversable RT?	N/A
N/A	Landing Length (in)	N/A	N/A	DWS Provided?	N/A
N/A	Landing Width (in)	N/A	N/A	DWS Contrast?	N/A
N/A	Landing Slope (%)	N/A	N/A	DWS Length (in)	N/A
N/A	Landing X Slope (%)	N/A	N/A	DWS Full Width?	N/A
N/A	Landing Curb? (Y/N)	N/A	N/A	DWS Offset (in)	N/A
N/A	Shared Landing?	N/A			
N/A	Gutter Ponding?	N/A	N/A	Gutter Slope (%)	N/A
N/A	Gutter Lip Ht (in)	N/A	N/A	Gutter X Slope (%)	N/A
N/A	Painted X Walk1?	Yes	N/A	Painted X Walk2?	No
	X Walk 1 Direction	To N		X Walk 2 Direction	To W
N/A	X Walk 1 Width (in)	101.0	N/A	X Walk 2 Width (in)	N/A
	X Walk 1 Slope (%)	3.6		X Walk 2 Slope (%)	3.5
	X Walk 1 X Slope (%)	1.8		X Walk 2 X Slope (%)	1.9

Remove & Replace Curb Ramp With Two New Directional Ramps or Equivalent.
