Access Compliance Report
Public Rights-of-Way
(Curb Ramps)

Intersection ID: 16208	**Main Street:** MARVIN_RD	**Cross Street:** BILLINGSLEY_RD	**Location:** NW
ADA ID: 7514E03E1D19	**Ramp Type:** PerpDiag	**Initial Pass/Fail:** Fail **Overall Compliance:** No	**Severity Score:** 21.25

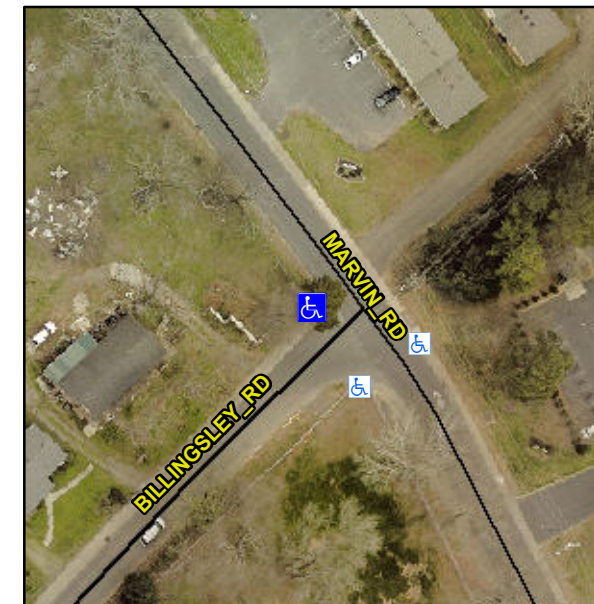
Not Found, R304.5.1, R304.2.2

Compliance	Description	Data	Compliance	Description	Data
N/A	Ramp Length (in)	60.0	No	Ramp Slope (%)	10.0
No	Ramp Width (in)	37.5	Yes	Ramp XSlope (%)	1.8
N/A	Flare Type LT	N/A	N/A	Flare Type RT	N/A
N/A	Flare Slope LT (%)	N/A	N/A	Flare Slope RT (%)	N/A
N/A	Flare Traversable LT?	N/A	N/A	Flare Traversable RT?	N/A
N/A	Landing Length (in)	N/A	N/A	DWS Provided?	N/A
N/A	Landing Width (in)	N/A	N/A	DWS Contrast?	N/A
N/A	Landing Slope (%)	N/A	N/A	DWS Length (in)	N/A
N/A	Landing X Slope (%)	N/A	N/A	DWS Full Width?	N/A
N/A	Landing Curb? (Y/N)	N/A	N/A	DWS Offset (in)	N/A
N/A	Shared Landing?	N/A			
N/A	Gutter Ponding?	N/A	N/A	Gutter Slope (%)	N/A
N/A	Gutter Lip Ht (in)	N/A	N/A	Gutter X Slope (%)	N/A
N/A	Painted X Walk1?	No	N/A	Painted X Walk2?	No
	X Walk 1 Direction	To SE		X Walk 2 Direction	To NE
N/A	X Walk 1 Width (in)	N/A	N/A	X Walk 2 Width (in)	N/A
	X Walk 1 Slope (%)	7.3		X Walk 2 Slope (%)	1.9
	X Walk 1 X Slope (%)	1.2		X Walk 2 X Slope (%)	4.7

Remove & Replace Curb Ramp With Two New Directional Ramps or Equivalent.
