Access Compliance Report
Public Rights-of-Way
(Curb Ramps)

Intersection ID: 42667	Main Street: WALLACE_GLEN_DR	Cross Street: WALLACE_VIEW_CT	Location:	SW
ADA ID: 75A52F6A6151	Ramp Type: PerpDiag	Initial Pass/Fail: Fail	Overall Compliance: No	Severity Score: 10

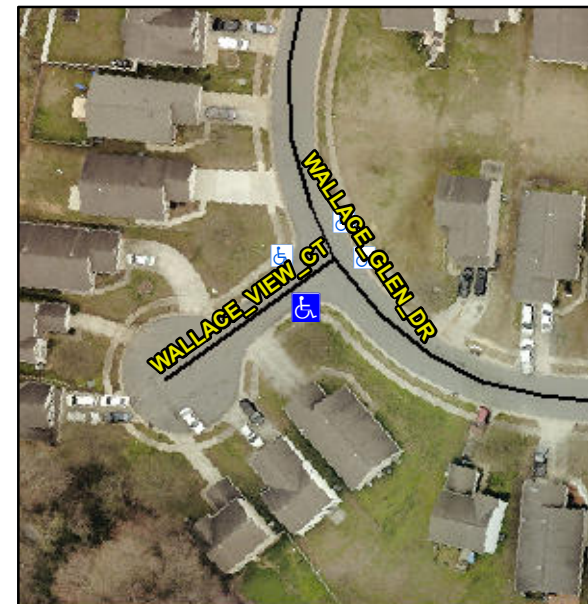
R304.5.1, R304.5.3

Compliance	Description	Data	Compliance	Description	Data
N/A	Ramp Length (in)	48.0	Yes	Ramp Slope (%)	8.1
No	Ramp Width (in)	44.0	No	Ramp XSlope (%)	3.4
N/A	Flare Type LT	N/A	N/A	Flare Type RT	N/A
N/A	Flare Slope LT (%)	N/A	N/A	Flare Slope RT (%)	N/A
N/A	Flare Traversable LT?	N/A	N/A	Flare Traversable RT?	N/A
N/A	Landing Length (in)	N/A	N/A	DWS Provided?	N/A
N/A	Landing Width (in)	N/A	N/A	DWS Contrast?	N/A
N/A	Landing Slope (%)	N/A	N/A	DWS Length (in)	N/A
N/A	Landing X Slope (%)	N/A	N/A	DWS Full Width?	N/A
N/A	Landing Curb? (Y/N)	N/A	N/A	DWS Offset (in)	N/A
N/A	Shared Landing?	N/A			
N/A	Gutter Ponding?	N/A	N/A	Gutter Slope (%)	N/A
N/A	Gutter Lip Ht (in)	N/A	N/A	Gutter X Slope (%)	N/A
N/A	Painted X Walk1?	No	N/A	Painted X Walk2?	No
	X Walk 1 Direction	To E		X Walk 2 Direction	To N
N/A	X Walk 1 Width (in)	N/A	N/A	X Walk 2 Width (in)	N/A
	X Walk 1 Slope (%)	2.2		X Walk 2 Slope (%)	1.6
	X Walk 1 X Slope (%)	1.9		X Walk 2 X Slope (%)	2.3

Remove & Replace Curb Ramp With Two New Directional Ramps or Equivalent.
