# Access Compliance Report
# Public Rights-of-Way
# (Curb Ramps)

| **Intersection ID:** 10143 | **Main Street:** E_34TH_ST | **Cross Street:** N_DAVIDSON_ST | **Location:** S |
| **ADA ID:** 7837A4A29F7B | **Ramp Type:** PerpDiag | **Initial Pass/Fail:** Fail **Overall Compliance:** No | **Severity Score:** 12.5 |

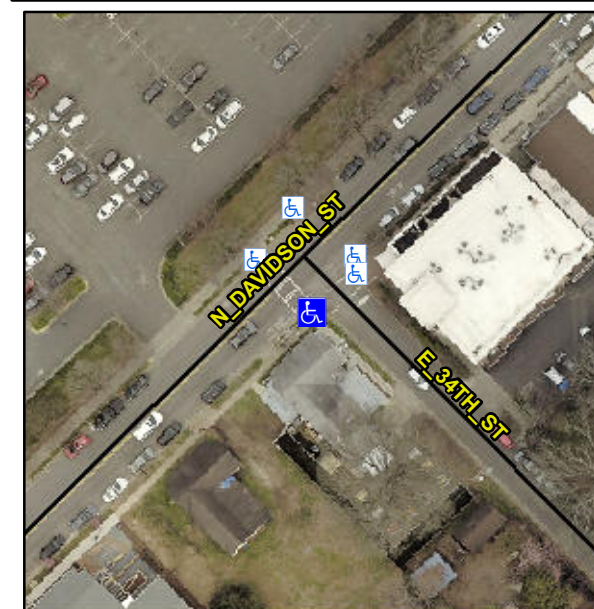
**R304.2.2**

| Compliance | Description | Data | Compliance | Description | Data |
|---|---|---|---|---|---|
| N/A | Ramp Length (in) | 33.0 | No | Ramp Slope (%) | 11.4 |

**Remove & Replace Curb Ramp With Two New Directional Ramps or Equivalent.**
