Access Compliance Report
Public Rights-of-Way
(Curb Ramps)

Intersection ID: 31934	**Main Street: STEELE_CREEK_RD**	**Cross Street: BRANCH_BEND_LN**	**Location:**	**SE**
ADA ID: 787DE1D7C6D5	**Ramp Type: PerpDiag**	**Initial Pass/Fail: Fail**	**Overall Compliance: No**	**Severity Score: 17.5**

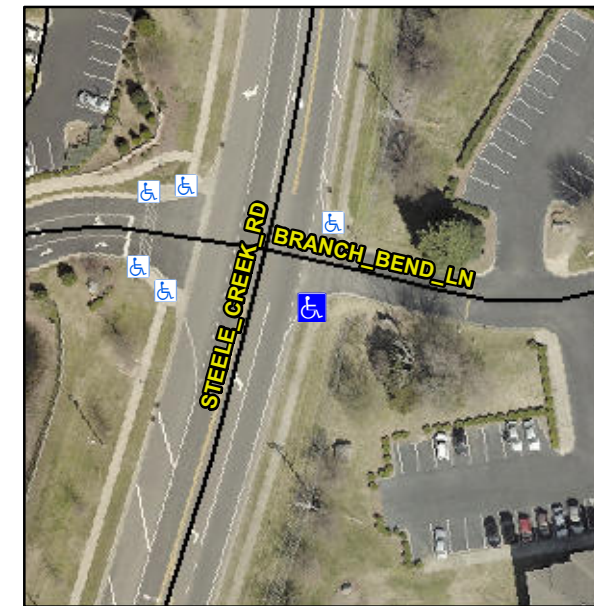
Not Found, R304.5.1

Compliance	Description	Data	Compliance	Description	Data
N/A	Ramp Length (in)	111.0	Yes	Ramp Slope (%)	5.7
No	Ramp Width (in)	35.0	Yes	Ramp XSlope (%)	0.1
N/A	Flare Type LT	N/A	N/A	Flare Type RT	N/A
N/A	Flare Slope LT (%)	N/A	N/A	Flare Slope RT (%)	N/A
N/A	Flare Traversable LT?	N/A	N/A	Flare Traversable RT?	N/A
N/A	Landing Length (in)	N/A	N/A	DWS Provided?	N/A
N/A	Landing Width (in)	N/A	N/A	DWS Contrast?	N/A
N/A	Landing Slope (%)	N/A	N/A	DWS Length (in)	N/A
N/A	Landing X Slope (%)	N/A	N/A	DWS Full Width?	N/A
N/A	Landing Curb? (Y/N)	N/A	N/A	DWS Offset (in)	N/A
N/A	Shared Landing?	N/A			
N/A	Gutter Ponding?	N/A	N/A	Gutter Slope (%)	N/A
N/A	Gutter Lip Ht (in)	N/A	N/A	Gutter X Slope (%)	N/A
N/A	Painted X Walk1?	No	N/A	Painted X Walk2?	No
	X Walk 1 Direction	To NE		X Walk 2 Direction	To NW
N/A	X Walk 1 Width (in)	N/A	N/A	X Walk 2 Width (in)	N/A
	X Walk 1 Slope (%)	1.6		X Walk 2 Slope (%)	0.8
	X Walk 1 X Slope (%)	2.2		X Walk 2 X Slope (%)	3.3

N/A	Ramp inside XWalk1?	N/A	N/A	Ramp inside XWalk2?	N/A
	Road Slope (%)	0.4	N/A	Clear Space?	N/A
	Road X Slope (%)	2.4	N/A	Clear Space to XWalk (in)	N/A
N/A	Any Obstructions?	N/A	N/A	Storm Grate/Utility Hazard?	N/A
	Obstruction Type			Storm Grate/Utility Type	
N/A					N/A
			Yes	Surface Condition? (G/P)	Good

Remove & Replace Curb Ramp With Two New Directional Ramps or Equivalent.
