Access Compliance Report
Public Rights-of-Way
(Curb Ramps)

Intersection ID: 21972	Main Street: ENGLAND_ST	Cross Street: PENINSULA_LN	Location:	NW
ADA ID: 79D176BBFCD1	Ramp Type: PerpDiag	Initial Pass/Fail: Fail	Overall Compliance: No	Severity Score: 12.5

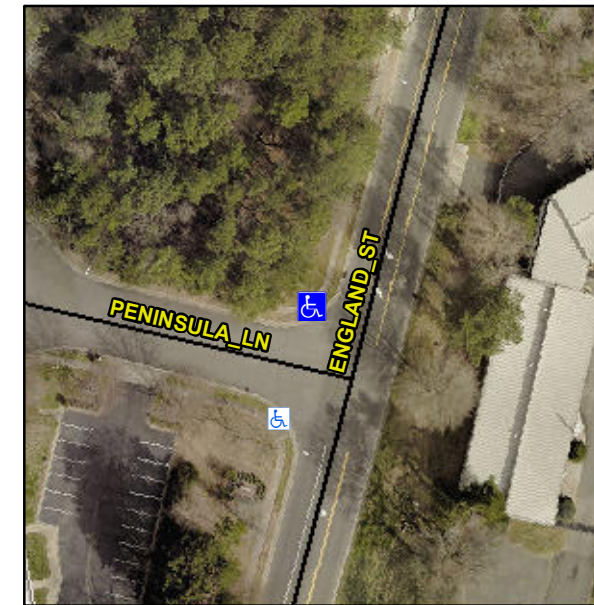
Not Found, R304.2.2

Compliance	Description	Data	Compliance	Description	Data
N/A	Ramp Length (in)	93.0	No	Ramp Slope (%)	8.5
Yes	Ramp Width (in)	48.0	Yes	Ramp XSlope (%)	0.8
N/A	Flare Type LT	N/A	N/A	Flare Type RT	N/A
N/A	Flare Slope LT (%)	N/A	N/A	Flare Slope RT (%)	N/A
N/A	Flare Traversable LT?	N/A	N/A	Flare Traversable RT?	N/A
N/A	Landing Length (in)	N/A	N/A	DWS Provided?	N/A
N/A	Landing Width (in)	N/A	N/A	DWS Contrast?	N/A
N/A	Landing Slope (%)	N/A	N/A	DWS Length (in)	N/A
N/A	Landing X Slope (%)	N/A	N/A	DWS Full Width?	N/A
N/A	Landing Curb? (Y/N)	N/A	N/A	DWS Offset (in)	N/A
N/A	Shared Landing?	N/A			
N/A	Gutter Ponding?	N/A	N/A	Gutter Slope (%)	N/A
N/A	Gutter Lip Ht (in)	N/A	N/A	Gutter X Slope (%)	N/A
N/A	Painted X Walk1?	No	N/A	Painted X Walk2?	No
	X Walk 1 Direction	To SW		X Walk 2 Direction	To SE
N/A	X Walk 1 Width (in)	N/A	N/A	X Walk 2 Width (in)	N/A
	X Walk 1 Slope (%)	1.3		X Walk 2 Slope (%)	2.5
	X Walk 1 X Slope (%)	3.3		X Walk 2 X Slope (%)	1.3

Remove & Replace Curb Ramp With Two New Directional Ramps or Equivalent.
