Access Compliance Report
Public Rights-of-Way
(Curb Ramps)

Intersection ID: 29125 **Main Street:** ALDERPOINT_LN **Cross Street:** APPLEDALE_DR **Location:** W

ADA ID: 7B522F41764F **Ramp Type:** PerpDiag **Initial Pass/Fail:** Fail **Overall Compliance:** No **Severity Score:** 1.25

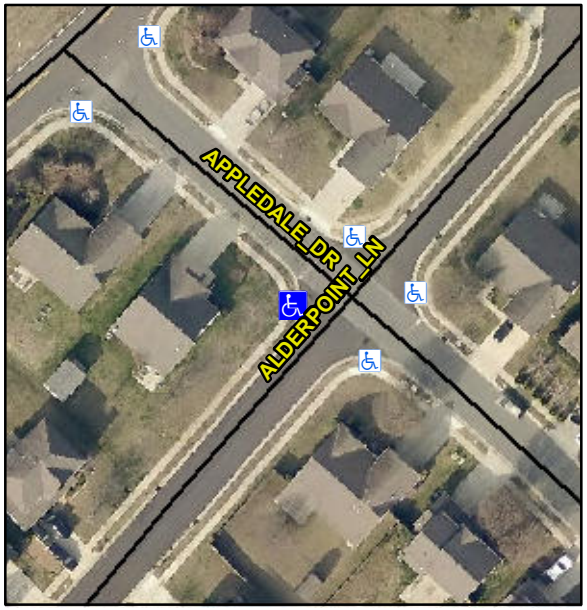
Not Found, R304.5.3

Compliance	Description	Data	Compliance	Description	Data
N/A	Ramp Length (in)	59.0	Yes	Ramp Slope (%)	5.7
Yes	Ramp Width (in)	120.0	No	Ramp XSlope (%)	4.9
N/A	Flare Type LT	N/A	N/A	Flare Type RT	N/A
N/A	Flare Slope LT (%)	N/A	N/A	Flare Slope RT (%)	N/A
N/A	Flare Traversable LT?	N/A	N/A	Flare Traversable RT?	N/A
N/A	Landing Length (in)	N/A	N/A	DWS Provided?	N/A
N/A	Landing Width (in)	N/A	N/A	DWS Contrast?	N/A
N/A	Landing Slope (%)	N/A	N/A	DWS Length (in)	N/A
N/A	Landing X Slope (%)	N/A	N/A	DWS Full Width?	N/A
N/A	Landing Curb? (Y/N)	N/A	N/A	DWS Offset (in)	N/A
N/A	Shared Landing?	N/A			
N/A	Gutter Ponding?	N/A	N/A	Gutter Slope (%)	N/A
N/A	Gutter Lip Ht (in)	N/A	N/A	Gutter X Slope (%)	N/A
N/A	Painted X Walk1?	No	N/A	Painted X Walk2?	No
	X Walk 1 Direction	To SE		X Walk 2 Direction	To NE
N/A	X Walk 1 Width (in)	N/A	N/A	X Walk 2 Width (in)	N/A
	X Walk 1 Slope (%)	0.4		X Walk 2 Slope (%)	4.3
	X Walk 1 X Slope (%)	4.9		X Walk 2 X Slope (%)	2.0

Remove & Replace Curb Ramp With Two New Directional Ramps or Equivalent.
