Access Compliance Report
Public Rights-of-Way
(Curb Ramps)

Intersection ID: 10027985	Main Street: HARLINGTON_LN	Cross Street: N/A	Location:	NE
ADA ID: 7B5D7389FF2F	Ramp Type: Perp	Initial Pass/Fail: Fail	Overall Compliance: No	Severity Score: 8.75

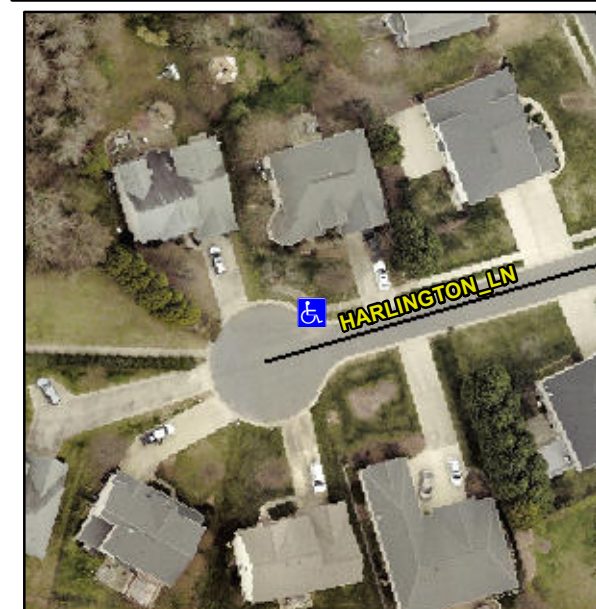
Not Found, R304.5.1

Compliance	Description	Data	Compliance	Description	Data
N/A	Ramp Length (in)	49.0	Yes	Ramp Slope (%)	5.0
No	Ramp Width (in)	39.0	Yes	Ramp XSlope (%)	0.9
N/A	Flare Type LT	N/A	N/A	Flare Type RT	N/A
N/A	Flare Slope LT (%)	N/A	N/A	Flare Slope RT (%)	N/A
N/A	Flare Traversable LT?	N/A	N/A	Flare Traversable RT?	N/A
N/A	Landing Length (in)	N/A	N/A	DWS Provided?	N/A
N/A	Landing Width (in)	N/A	N/A	DWS Contrast?	N/A
N/A	Landing Slope (%)	N/A	N/A	DWS Length (in)	N/A
N/A	Landing X Slope (%)	N/A	N/A	DWS Full Width?	N/A
N/A	Landing Curb? (Y/N)	N/A	N/A	DWS Offset (in)	N/A
N/A	Shared Landing?	N/A			
N/A	Gutter Ponding?	N/A	N/A	Gutter Slope (%)	N/A
N/A	Gutter Lip Ht (in)	N/A	N/A	Gutter X Slope (%)	N/A
N/A	Painted X Walk1?	No	N/A	Painted X Walk2?	N/A
	X Walk 1 Direction	To S		X Walk 2 Direction	N/A
N/A	X Walk 1 Width (in)	N/A	N/A	X Walk 2 Width (in)	N/A
	X Walk 1 Slope (%)	1.3		X Walk 2 Slope (%)	N/A
	X Walk 1 X Slope (%)	1.1		X Walk 2 X Slope (%)	N/A

Remove & Replace Entire Ramp.
