Access Compliance Report

# Public Rights-of-Way
(Curb Ramps)

Intersection ID: 26409	Main Street: KUYKENDALL_RD	Cross Street: PROVIDENCE_RD	Location:	NE
ADA ID: 7C2E74A476F9	Ramp Type: PerpDiag	Initial Pass/Fail: Fail	Overall Compliance: No	Severity Score: 8.75

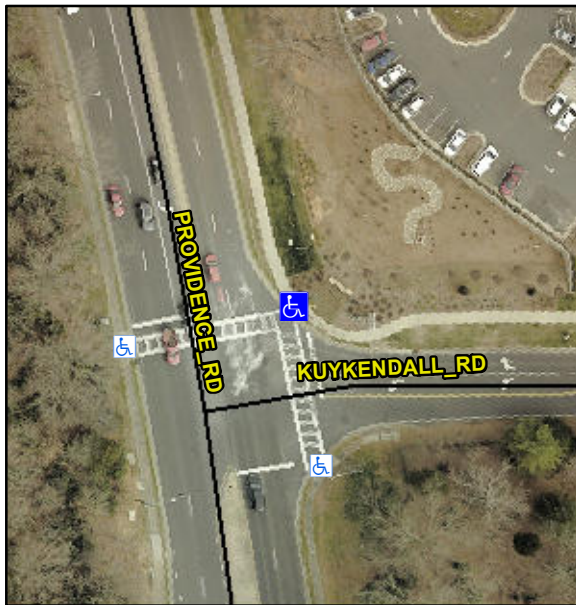
Not Found, R304.5.1

Compliance	Description	Data	Compliance	Description	Data
N/A	Ramp Length (in)	84.0	Yes	Ramp Slope (%)	7.6
No	Ramp Width (in)	47.0	Yes	Ramp XSlope (%)	1.6
N/A	Flare Type LT	N/A	N/A	Flare Type RT	N/A
N/A	Flare Slope LT (%)	N/A	N/A	Flare Slope RT (%)	N/A
N/A	Flare Traversable LT?	N/A	N/A	Flare Traversable RT?	N/A
N/A	Landing Length (in)	N/A	N/A	DWS Provided?	N/A
N/A	Landing Width (in)	N/A	N/A	DWS Contrast?	N/A
N/A	Landing Slope (%)	N/A	N/A	DWS Length (in)	N/A
N/A	Landing X Slope (%)	N/A	N/A	DWS Full Width?	N/A
N/A	Landing Curb? (Y/N)	N/A	N/A	DWS Offset (in)	N/A
N/A	Shared Landing?	N/A			
N/A	Gutter Ponding?	N/A	N/A	Gutter Slope (%)	N/A
N/A	Gutter Lip Ht (in)	N/A	N/A	Gutter X Slope (%)	N/A
N/A	Painted X Walk1?	Yes	N/A	Painted X Walk2?	Yes
	X Walk 1 Direction	To W		X Walk 2 Direction	To S
	X Walk 1 Width (in)	75.0	N/A	X Walk 2 Width (in)	92.0
	X Walk 1 Slope (%)	4.3		X Walk 2 Slope (%)	1.9
	X Walk 1 X Slope (%)	2.2		X Walk 2 X Slope (%)	2.8

Remove & Replace Curb Ramp With Two New Directional Ramps or Equivalent.
