Access Compliance Report
Public Rights-of-Way
(Curb Ramps)

Intersection ID: N/A	Main Street: **CRESSWIND BV**	Cross Street: **TREESDALE LN**	Location:	**E**
ADA ID: **7CBD0DF6FB68**	Ramp Type: **Perp**	Initial Pass/Fail: **Fail**	Overall Compliance: **No**	Severity Score: **1.25**

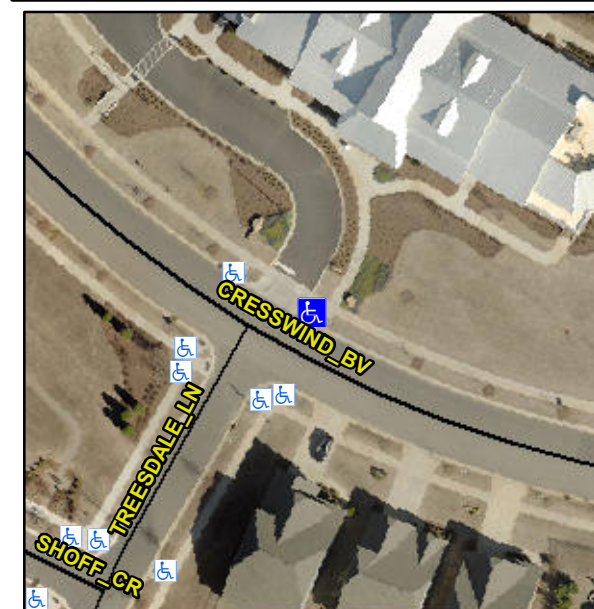
Not Found, R304.5.3

Compliance	Description	Data	Compliance	Description	Data
N/A	Ramp Length (in)	96.6	Yes	Ramp Slope (%)	5.4
Yes	Ramp Width (in)	59.0	No	Ramp XSlope (%)	2.6
N/A	Flare Type LT	N/A	N/A	Flare Type RT	N/A
N/A	Flare Slope LT (%)	N/A	N/A	Flare Slope RT (%)	N/A
N/A	Flare Traversable LT?	No	N/A	Flare Traversable RT?	No
N/A	Landing Length (in)	N/A	N/A	DWS Provided?	N/A
N/A	Landing Width (in)	N/A	N/A	DWS Contrast?	N/A
N/A	Landing Slope (%)	N/A	N/A	DWS Length (in)	N/A
N/A	Landing X Slope (%)	N/A	N/A	DWS Full Width?	N/A
N/A	Landing Curb? (Y/N)	N/A	N/A	DWS Offset (in)	N/A
N/A	Shared Landing?	N/A			
N/A	Gutter Ponding?	N/A	N/A	Gutter Slope (%)	N/A
N/A	Gutter Lip Ht (in)	N/A	N/A	Gutter X Slope (%)	N/A
N/A	Painted X Walk1?	No	N/A	Painted X Walk2?	N/A
	X Walk 1 Direction	To SW		X Walk 2 Direction	N/A
N/A	X Walk 1 Width (in)	N/A	N/A	X Walk 2 Width (in)	N/A
	X Walk 1 Slope (%)	2.6		X Walk 2 Slope (%)	N/A
	X Walk 1 X Slope (%)	0.7		X Walk 2 X Slope (%)	N/A

Remove & Replace Entire Ramp.
