Access Compliance Report
Public Rights-of-Way
(Curb Ramps)

Intersection ID: 32283	Main Street: MYERS_MILL_LN	Cross Street: LANDING_PLACE_LN	Location:	NW
ADA ID: 7D07543EBDF4	Ramp Type: PerpDiag	Initial Pass/Fail: Fail	Overall Compliance: No	Severity Score: 33.75

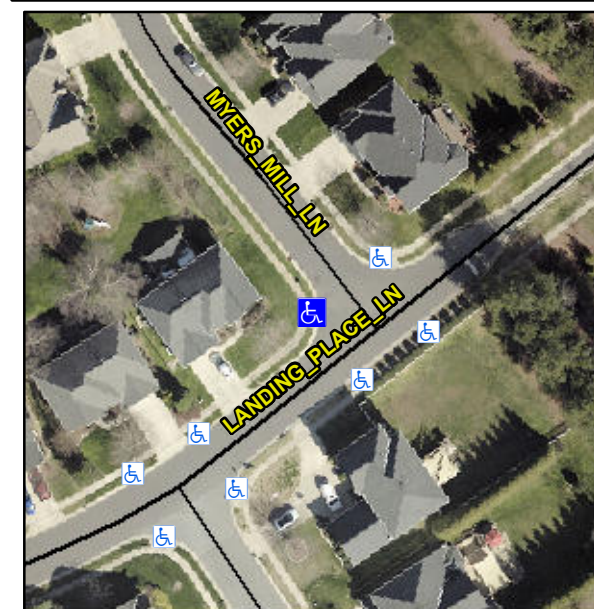
R304.5.1, R304.2.2

Compliance	Description	Data	Compliance	Description	Data
N/A	Ramp Length (in)	46.0	No	Ramp Slope (%)	14.6
No	Ramp Width (in)	36.5	Yes	Ramp XSlope (%)	0.4
N/A	Flare Type LT	N/A	N/A	Flare Type RT	N/A
N/A	Flare Slope LT (%)	N/A	N/A	Flare Slope RT (%)	N/A
N/A	Flare Traversable LT?	N/A	N/A	Flare Traversable RT?	N/A
N/A	Landing Length (in)	N/A	N/A	DWS Provided?	N/A
N/A	Landing Width (in)	N/A	N/A	DWS Contrast?	N/A
N/A	Landing Slope (%)	N/A	N/A	DWS Length (in)	N/A
N/A	Landing X Slope (%)	N/A	N/A	DWS Full Width?	N/A
N/A	Landing Curb? (Y/N)	N/A	N/A	DWS Offset (in)	N/A
N/A	Shared Landing?	N/A			
N/A	Gutter Ponding?	N/A	N/A	Gutter Slope (%)	N/A
N/A	Gutter Lip Ht (in)	N/A	N/A	Gutter X Slope (%)	N/A
N/A	Painted X Walk1?	No	N/A	Painted X Walk2?	No
	X Walk 1 Direction	To SE		X Walk 2 Direction	To NE
N/A	X Walk 1 Width (in)	N/A	N/A	X Walk 2 Width (in)	N/A
	X Walk 1 Slope (%)	1.6		X Walk 2 Slope (%)	0.3
	X Walk 1 X Slope (%)	0.6		X Walk 2 X Slope (%)	2.1

Remove & Replace Curb Ramp With Two New Directional Ramps or Equivalent.
