Access Compliance Report
Public Rights-of-Way
(Curb Ramps)

Intersection ID: 2715 **Main Street:** CROWNVISTA_DR **Cross Street:** DAWNMIST_LN **Location:** N

ADA ID: 7DF79A2A183B **Ramp Type:** PerpDiag **Initial Pass/Fail:** Fail **Overall Compliance:** No **Severity Score:** 21.25

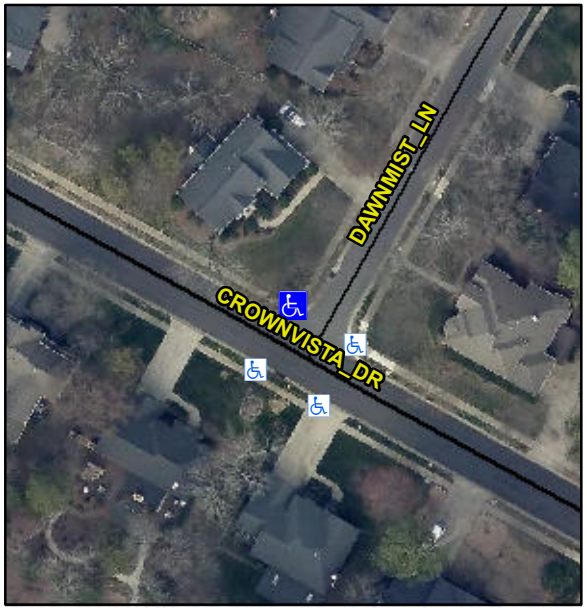
Not Found, R304.5.1, R304.5.3

Compliance	Description	Data	Compliance	Description	Data
N/A	Ramp Length (in)	46.0	Yes	Ramp Slope (%)	6.9
No	Ramp Width (in)	37.0	No	Ramp XSlope (%)	6.8
N/A	Flare Type LT	N/A	N/A	Flare Type RT	N/A
N/A	Flare Slope LT (%)	N/A	N/A	Flare Slope RT (%)	N/A
N/A	Flare Traversable LT?	N/A	N/A	Flare Traversable RT?	N/A
N/A	Landing Length (in)	N/A	N/A	DWS Provided?	N/A
N/A	Landing Width (in)	N/A	N/A	DWS Contrast?	N/A
N/A	Landing Slope (%)	N/A	N/A	DWS Length (in)	N/A
N/A	Landing X Slope (%)	N/A	N/A	DWS Full Width?	N/A
N/A	Landing Curb? (Y/N)	N/A	N/A	DWS Offset (in)	N/A
N/A	Shared Landing?	N/A			
N/A	Gutter Ponding?	N/A	N/A	Gutter Slope (%)	N/A
N/A	Gutter Lip Ht (in)	N/A	N/A	Gutter X Slope (%)	N/A
N/A	Painted X Walk1?	No	N/A	Painted X Walk2?	No
	X Walk 1 Direction	To SW		X Walk 2 Direction	To SE
N/A	X Walk 1 Width (in)	N/A	N/A	X Walk 2 Width (in)	N/A
	X Walk 1 Slope (%)	4.7		X Walk 2 Slope (%)	1.3
	X Walk 1 X Slope (%)	2.8		X Walk 2 X Slope (%)	4.6

Remove & Replace Curb Ramp With Two New Directional Ramps or Equivalent.
