Access Compliance Report
Public Rights-of-Way
(Curb Ramps)

Intersection ID: 22500	**Main Street: CHADMORE_SOUTH_DR**	**Cross Street: HARRISONWOODS_PL**	**Location:**	**W**
ADA ID: 7E572E32E469	**Ramp Type: PerpDiag**	**Initial Pass/Fail: Fail**	**Overall Compliance: No**	**Severity Score: 25**

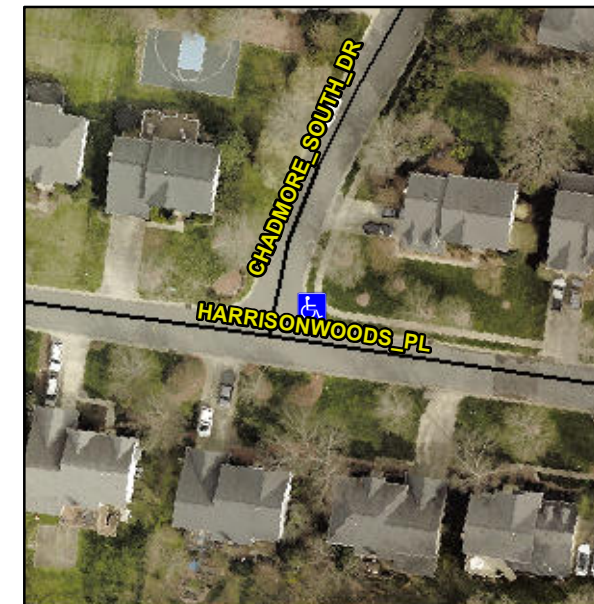
Not Found, R304.2.2, R304.5.3

Compliance	Description	Data	Compliance	Description	Data
N/A	Ramp Length (in)	45.5	No	Ramp Slope (%)	9.3
Yes	Ramp Width (in)	48.0	No	Ramp XSlope (%)	6.2
N/A	Flare Type LT	N/A	N/A	Flare Type RT	N/A
N/A	Flare Slope LT (%)	N/A	N/A	Flare Slope RT (%)	N/A
N/A	Flare Traversable LT?	N/A	N/A	Flare Traversable RT?	N/A
N/A	Landing Length (in)	N/A	N/A	DWS Provided?	N/A
N/A	Landing Width (in)	N/A	N/A	DWS Contrast?	N/A
N/A	Landing Slope (%)	N/A	N/A	DWS Length (in)	N/A
N/A	Landing X Slope (%)	N/A	N/A	DWS Full Width?	N/A
N/A	Landing Curb? (Y/N)	N/A	N/A	DWS Offset (in)	N/A
N/A	Shared Landing?	N/A			
N/A	Gutter Ponding?	N/A	N/A	Gutter Slope (%)	N/A
N/A	Gutter Lip Ht (in)	N/A	N/A	Gutter X Slope (%)	N/A
N/A	Painted X Walk1?	No	N/A	Painted X Walk2?	No
	X Walk 1 Direction	To NE		X Walk 2 Direction	To SW
N/A	X Walk 1 Width (in)	N/A	N/A	X Walk 2 Width (in)	N/A
	X Walk 1 Slope (%)	5.6		X Walk 2 Slope (%)	1.1
	X Walk 1 X Slope (%)	0.7		X Walk 2 X Slope (%)	4.1

N/A	Ramp inside XWalk1?	N/A	N/A	Ramp inside XWalk2?	N/A
	Road Slope (%)	3.7	N/A	Clear Space?	N/A
	Road X Slope (%)	5.4	N/A	Clear Space to XWalk (in)	N/A
N/A	Any Obstructions?	N/A	N/A	Storm Grate/Utility Hazard?	N/A
	Obstruction Type			Storm Grate/Utility Type	
N/A					N/A
			Yes	Surface Condition? (G/P)	Good

Remove & Replace Curb Ramp With Two New Directional Ramps or Equivalent.
