Access Compliance Report
Public Rights-of-Way
(Curb Ramps)

Intersection ID: 4861 **Main Street:** HEDGECREST_PL **Cross Street:** MOSSY_BANK_PL **Location:** NE

ADA ID: 7F2393E96399 **Ramp Type:** Perp **Initial Pass/Fail:** Fail **Overall Compliance:** No **Severity Score:** 1.25

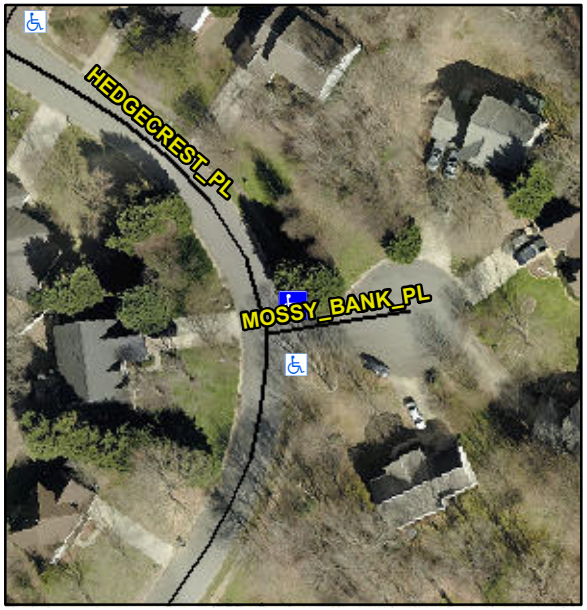
Not Found, R304.5.3

Remove & Replace Entire Ramp.
