Access Compliance Report
Public Rights-of-Way
(Curb Ramps)

Intersection ID: 51370	**Main Street:** UNIVERSITY_POINTE_BV	**Cross Street:** IKEA_BV	**Location:** SE
ADA ID: 7F29D439BC1B	**Ramp Type:** PerpDiag	**Initial Pass/Fail:** Fail	**Overall Compliance:** No **Severity Score:** 25

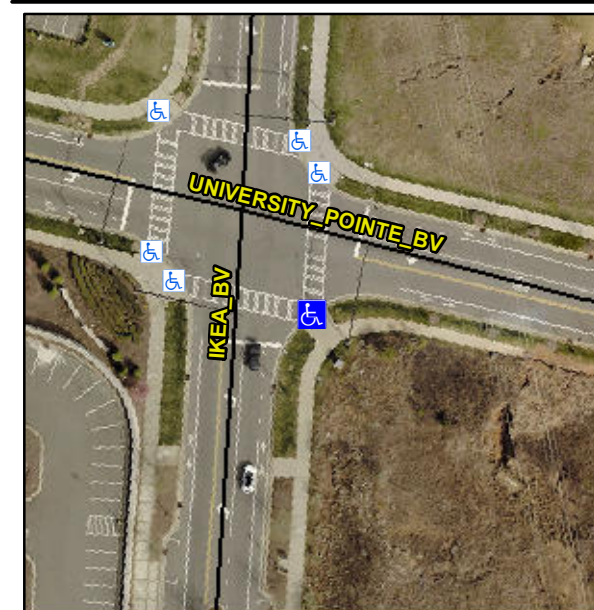
Not Found, R304.5.3

Compliance	Description	Data	Compliance	Description	Data
N/A	Ramp Length (in)	138.0	Yes	Ramp Slope (%)	6.5
Yes	Ramp Width (in)	58.0	No	Ramp XSlope (%)	10.0
N/A	Flare Type LT	N/A	N/A	Flare Type RT	N/A
N/A	Flare Slope LT (%)	N/A	N/A	Flare Slope RT (%)	N/A
N/A	Flare Traversable LT?	N/A	N/A	Flare Traversable RT?	N/A
N/A	Landing Length (in)	N/A	N/A	DWS Provided?	N/A
N/A	Landing Width (in)	N/A	N/A	DWS Contrast?	N/A
N/A	Landing Slope (%)	N/A	N/A	DWS Length (in)	N/A
N/A	Landing X Slope (%)	N/A	N/A	DWS Full Width?	N/A
N/A	Landing Curb? (Y/N)	N/A	N/A	DWS Offset (in)	N/A
N/A	Shared Landing?	N/A			
N/A	Gutter Ponding?	N/A	N/A	Gutter Slope (%)	N/A
N/A	Gutter Lip Ht (in)	N/A	N/A	Gutter X Slope (%)	N/A
N/A	Painted X Walk1?	Yes	N/A	Painted X Walk2?	Yes
	X Walk 1 Direction	To N		X Walk 2 Direction	To W
N/A	X Walk 1 Width (in)	112.0	N/A	X Walk 2 Width (in)	112.0
	X Walk 1 Slope (%)	5.5		X Walk 2 Slope (%)	5.4
	X Walk 1 X Slope (%)	3.8		X Walk 2 X Slope (%)	6.6

N/A	Ramp inside XWalk1?	Yes	N/A	Ramp inside XWalk2?	Yes
	Road Slope (%)	7.6	N/A	Clear Space?	N/A
	Road X Slope (%)	1.5	N/A	Clear Space to XWalk (in)	N/A
N/A	Any Obstructions?	N/A	N/A	Storm Grate/Utility Hazard?	N/A
	Obstruction Type			Storm Grate/Utility Type	
N/A					N/A
			Yes	Surface Condition? (G/P)	Good

Remove & Replace Curb Ramp With Two New Directional Ramps or Equivalent.
