Access Compliance Report
Public Rights-of-Way
(Curb Ramps)

Intersection ID: N/A	Main Street: ENDHAVEN_LN	Cross Street: N_COMMUNITY_HOUSE_RD	Location:	SE
ADA ID: 7F690EF47580	Ramp Type: Perp	Initial Pass/Fail: Fail	Overall Compliance: No	Severity Score: 13.75

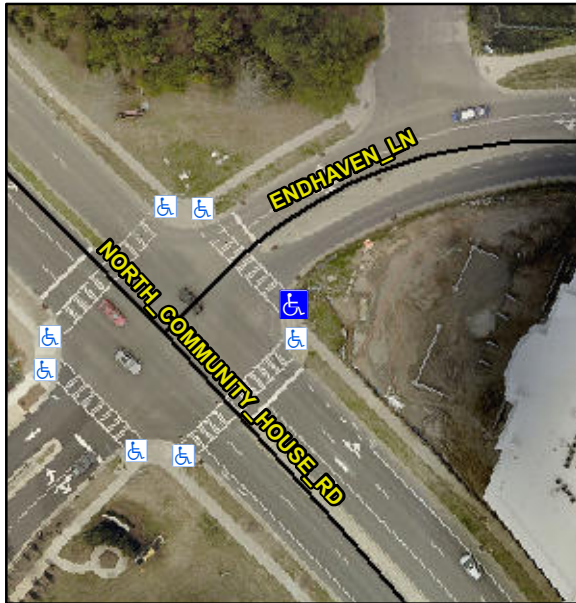
R304.2.2, R304.5.3

Compliance	Description	Data	Compliance	Description	Data
N/A	Ramp Length (in)	58.0	No	Ramp Slope (%)	8.9
Yes	Ramp Width (in)	48.0	No	Ramp XSlope (%)	4.6
N/A	Flare Type LT	N/A	N/A	Flare Type RT	N/A
N/A	Flare Slope LT (%)	N/A	N/A	Flare Slope RT (%)	N/A
N/A	Flare Traversable LT?	N/A	N/A	Flare Traversable RT?	N/A
N/A	Landing Length (in)	N/A	N/A	DWS Provided?	N/A
N/A	Landing Width (in)	N/A	N/A	DWS Contrast?	N/A
N/A	Landing Slope (%)	N/A	N/A	DWS Length (in)	N/A
N/A	Landing X Slope (%)	N/A	N/A	DWS Full Width?	N/A
N/A	Landing Curb? (Y/N)	N/A	N/A	DWS Offset (in)	N/A
N/A	Shared Landing?	N/A			
N/A	Gutter Ponding?	N/A	N/A	Gutter Slope (%)	N/A
N/A	Gutter Lip Ht (in)	N/A	N/A	Gutter X Slope (%)	N/A
N/A	Painted X Walk1?	Yes	N/A	Painted X Walk2?	N/A
	X Walk 1 Direction	To NW		X Walk 2 Direction	N/A
N/A	X Walk 1 Width (in)	114.5	N/A	X Walk 2 Width (in)	N/A
	X Walk 1 Slope (%)	1.6		X Walk 2 Slope (%)	N/A
	X Walk 1 X Slope (%)	2.0		X Walk 2 X Slope (%)	N/A

Remove & Replace Entire Ramp.
