Access Compliance Report
Public Rights-of-Way
(Curb Ramps)

Intersection ID: 11095 | **Main Street:** ASHLEY_RD | **Cross Street:** LIGGETT_ST | **Location:** N

ADA ID: 7F860630599E | **Ramp Type:** Perp | **Initial Pass/Fail:** Fail | **Overall Compliance:** No | **Severity Score:** 21.25

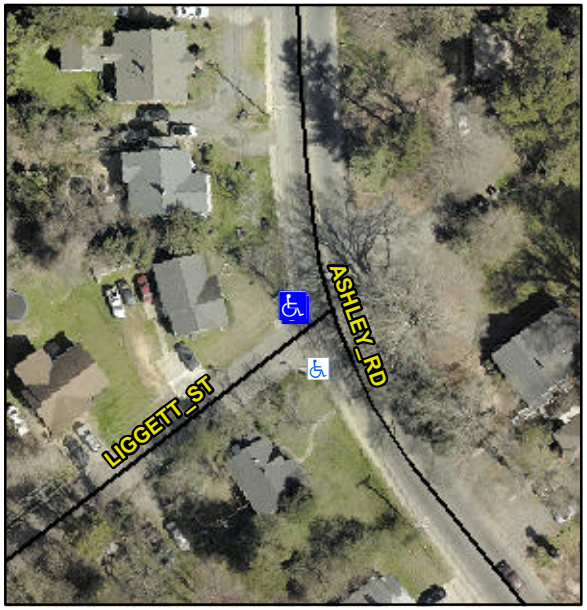
R304.5.1, R304.2.2

Compliance	Description	Data	Compliance	Description	Data
N/A	Ramp Length (in)	57.0	No	Ramp Slope (%)	11.9
No	Ramp Width (in)	46.0	Yes	Ramp XSlope (%)	1.1
N/A	Flare Type LT	N/A	N/A	Flare Type RT	N/A
N/A	Flare Slope LT (%)	N/A	N/A	Flare Slope RT (%)	N/A
N/A	Flare Traversable LT?	N/A	N/A	Flare Traversable RT?	N/A
N/A	Landing Length (in)	N/A	N/A	DWS Provided?	N/A
N/A	Landing Width (in)	N/A	N/A	DWS Contrast?	N/A
N/A	Landing Slope (%)	N/A	N/A	DWS Length (in)	N/A
N/A	Landing X Slope (%)	N/A	N/A	DWS Full Width?	N/A
N/A	Landing Curb? (Y/N)	N/A	N/A	DWS Offset (in)	N/A
N/A	Shared Landing?	N/A			
N/A	Gutter Ponding?	N/A	N/A	Gutter Slope (%)	N/A
N/A	Gutter Lip Ht (in)	N/A	N/A	Gutter X Slope (%)	N/A
N/A	Painted X Walk1?	No	N/A	Painted X Walk2?	N/A
	X Walk 1 Direction	To S		X Walk 2 Direction	N/A
N/A	X Walk 1 Width (in)	N/A	N/A	X Walk 2 Width (in)	N/A
	X Walk 1 Slope (%)	1.9		X Walk 2 Slope (%)	N/A
	X Walk 1 X Slope (%)	0.1		X Walk 2 X Slope (%)	N/A

Remove & Replace Entire Ramp.
