Access Compliance Report
Public Rights-of-Way
(Curb Ramps)

Intersection ID: 3272 **Main Street:** HIGHCROFT_LN **Cross Street:** WORSLEY_LN **Location:** NE

ADA ID: 7FDDC0C6F625 **Ramp Type:** Perp **Initial Pass/Fail:** Fail **Overall Compliance:** No **Severity Score:** 15

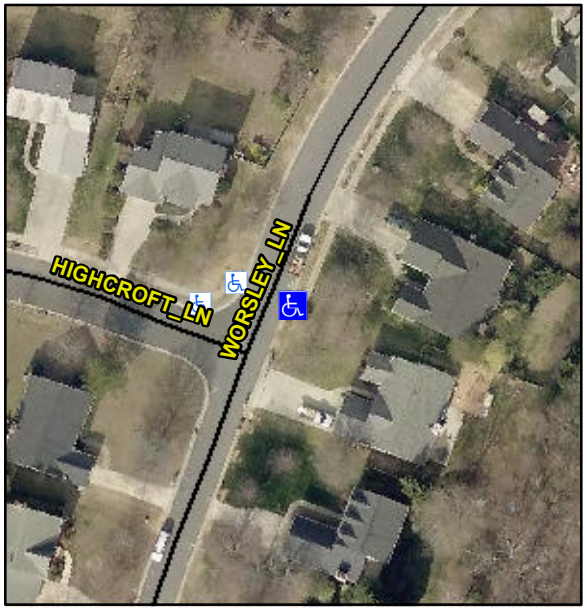
R302.7

N/A	Ramp inside XWalk1?	N/A	N/A	Ramp inside XWalk2?	N/A
	Road Slope (%)	N/A	N/A	Clear Space?	N/A
	Road X Slope (%)	N/A	N/A	Clear Space to XWalk (in)	N/A
N/A	Any Obstructions?	N/A	N/A	Storm Grate/Utility Hazard?	N/A
	Obstruction Type			Storm Grate/Utility Type	
		N/A			N/A
			No	Surface Condition? (G/P)	Poor

Remove & Replace Entire Ramp.
