Access Compliance Report
Public Rights-of-Way
(Curb Ramps)

Intersection ID: 14762	Main Street: E_TREMONT_AV	Cross Street: SPRINGDALE_AV	Location:	W
ADA ID: 805235A0FA09	Ramp Type: Directional1	Initial Pass/Fail: Fail	Overall Compliance: No	Severity Score: 37.5

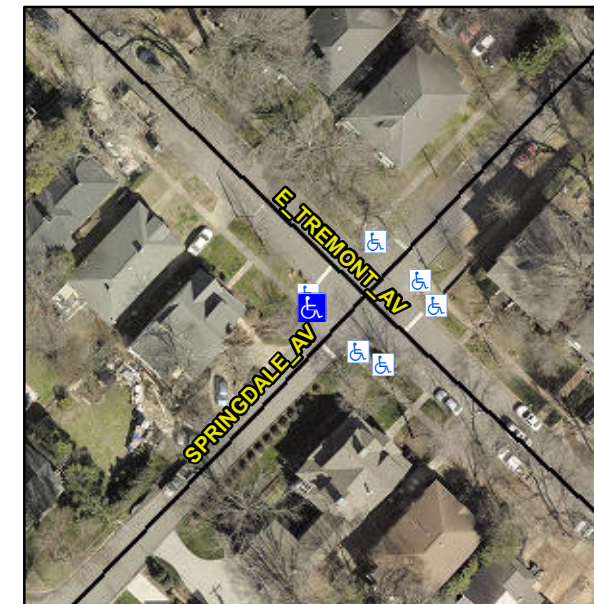
WATER VALVE LIP 1.0"

R304.2.2, R304.5.3

Remove & Replace Entire Ramp.
