Access Compliance Report
Public Rights-of-Way
(Curb Ramps)

Intersection ID: 12646	**Main Street:** LEVINE_AVENUE_OF_THE_ARTS	**Cross Street:** S_TRYON_ST	**Location:**	**E**
ADA ID: 8114C9FAE72B	**Ramp Type: Perp**	**Initial Pass/Fail: Pass**	**Overall Compliance: No**	**Severity Score: 10.25**

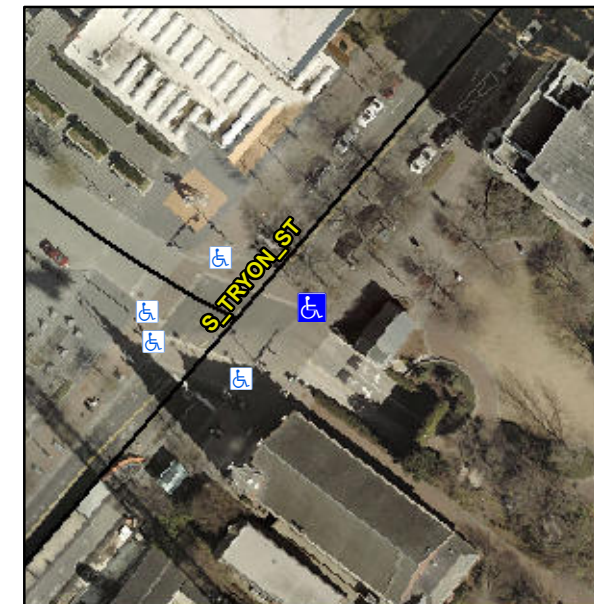
R304.5.3, R304.2.3, R305.1.4,
R304.5.4

Compliance	Description	Data	Compliance	Description	Data
N/A	Ramp Length (in)	87.0	Yes	Ramp Slope (%)	5.7
Yes	Ramp Width (in)	54.0	No	Ramp XSlope (%)	3.7
Yes	Flare Type LT	Curbed_NoWalkSurface	No	Flare Type RT	N/A
Yes	Flare Slope LT (%)	N/A	N/A	Flare Slope RT (%)	N/A
N/A	Flare Traversable LT?	No	N/A	Flare Traversable RT?	No
Yes	Landing Length (in)	60.0	Yes	DWS Provided?	Yes
Yes	Landing Width (in)	60.0	Yes	DWS Contrast?	Yes
Yes	Landing Slope (%)	0.4	No	DWS Length (in)	18.0
Yes	Landing X Slope (%)	1.4	Yes	DWS Full Width?	Yes
N/A	Landing Curb? (Y/N)	No	Yes	DWS Offset (in)	0.0
N/A	Shared Landing?	No			
Yes	Gutter Ponding?	No	No	Gutter Slope (%)	6.4
Yes	Gutter Lip Ht (in)	0.0	No	Gutter X Slope (%)	2.6
N/A	Painted X Walk1?	Yes	N/A	Painted X Walk2?	N/A
	X Walk 1 Direction	To NW		X Walk 2 Direction	N/A
N/A	X Walk 1 Width (in)	142.0	N/A	X Walk 2 Width (in)	N/A
	X Walk 1 Slope (%)	2.7		X Walk 2 Slope (%)	N/A
	X Walk 1 X Slope (%)	1.1		X Walk 2 X Slope (%)	N/A

Yes	Ramp inside XWalk1?	Yes	N/A	Ramp inside XWalk2?	N/A
	Road Slope (%)	N/A	N/A	Clear Space?	Yes
	Road X Slope (%)	N/A	N/A	Clear Space to XWalk (in)	N/A
Yes	Any Obstructions?	No	Yes	Storm Grate/Utility Hazard?	No
	Obstruction Type			Storm Grate/Utility Type	
		N/A			N/A
			Yes	Surface Condition? (G/P)	Good

Remove & Replace Entire Ramp.
Remove & Replace Gutter.
