Access Compliance Report

# Public Rights-of-Way
(Curb Ramps)

Intersection ID: 26389	Main Street: BONNIE_BUTLER_WY	Cross Street: TWELVE_OAKS_PL	Location:	NW
ADA ID: 81FEAC7C734D	Ramp Type: BlendTrans1	Initial Pass/Fail: Fail	Overall Compliance: No	Severity Score: 1.25

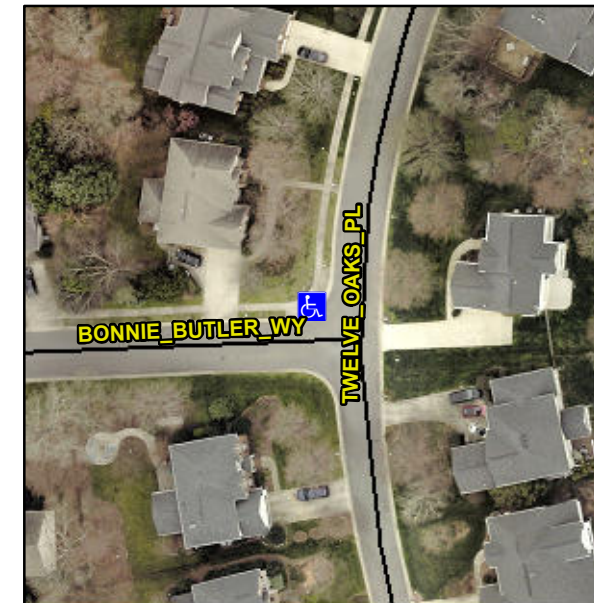
Not Found, R304.5.3

Compliance	Description	Data	Compliance	Description	Data
N/A	Ramp Length (in)	96.0	Yes	BlendTrans Slope (%)	3.7
Yes	Ramp Width (in)	48.0	No	BlendTrans XSlope (%)	3.6
N/A	Flare Type LT	N/A	N/A	Flare Type RT	N/A
N/A	Flare Slope LT (%)	N/A	N/A	Flare Slope RT (%)	N/A
N/A	Flare Traversable LT?	N/A	N/A	Flare Traversable RT?	N/A
N/A	Landing Length (in)	N/A	N/A	DWS Provided?	N/A
N/A	Landing Width (in)	N/A	N/A	DWS Contrast?	N/A
N/A	Landing Slope (%)	N/A	N/A	DWS Length (in)	N/A
N/A	Landing X Slope (%)	N/A	N/A	DWS Full Width?	N/A
N/A	Landing Curb? (Y/N)	N/A	N/A	DWS Offset (in)	N/A
N/A	Shared Landing?	N/A			
N/A	Gutter Ponding?	N/A	N/A	Gutter Slope (%)	N/A
N/A	Gutter Lip Ht (in)	N/A	N/A	Gutter X Slope (%)	N/A
N/A	Painted X Walk1?	No	N/A	Painted X Walk2?	No
	X Walk 1 Direction	To S		X Walk 2 Direction	To E
	X Walk 1 Width (in)	N/A		X Walk 2 Width (in)	N/A
	X Walk 1 Slope (%)	N/A		X Walk 2 Slope (%)	N/A
	X Walk 1 X Slope (%)	N/A		X Walk 2 X Slope (%)	N/A

N/A	Ramp inside XWalk1?	N/A	N/A	Ramp inside XWalk2?	N/A
	Road Slope (%)	5.6		Clear Space?	N/A
	Road X Slope (%)	2.6	N/A	Clear Space to XWalk (in)	N/A
N/A	Any Obstructions?	N/A	N/A	Storm Grate/Utility Hazard?	N/A
	Obstruction Type			Storm Grate/Utility Type	
			N/A		N/A
			Yes	Surface Condition? (G/P)	Good
			No	Curb Slope (%)	12.7

Remove & Replace Curb Ramp With Two New Directional Ramps or Equivalent.
