Access Compliance Report
Public Rights-of-Way
(Curb Ramps)

Intersection ID: N/A	Main Street: STRAWBERRY_FIELDS_LN	Cross Street: MAGGIE_MAY_LN		Location:	W
ADA ID: 82B76BAAD2FE	Ramp Type: Perp	Initial Pass/Fail: Fail	Overall Compliance: No	Severity Score:	8.75

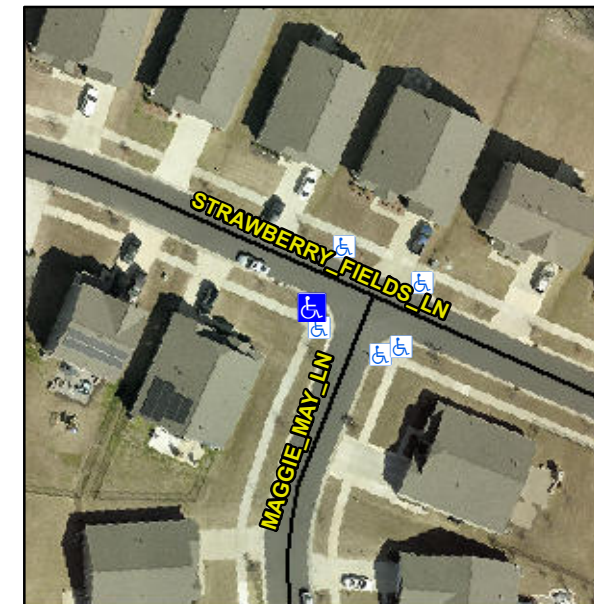
R304.5.1

Compliance	Description	Data	Compliance	Description	Data
N/A	Ramp Length (in)	98.5	Yes	Ramp Slope (%)	6.5
No	Ramp Width (in)	46.0	Yes	Ramp XSlope (%)	1.5
N/A	Flare Type LT	N/A	N/A	Flare Type RT	N/A
N/A	Flare Slope LT (%)	N/A	N/A	Flare Slope RT (%)	N/A
N/A	Flare Traversable LT?	N/A	N/A	Flare Traversable RT?	N/A
N/A	Landing Length (in)	N/A	N/A	DWS Provided?	N/A
N/A	Landing Width (in)	N/A	N/A	DWS Contrast?	N/A
N/A	Landing Slope (%)	N/A	N/A	DWS Length (in)	N/A
N/A	Landing X Slope (%)	N/A	N/A	DWS Full Width?	N/A
N/A	Landing Curb? (Y/N)	N/A	N/A	DWS Offset (in)	N/A
N/A	Shared Landing?	N/A			
N/A	Gutter Ponding?	N/A	N/A	Gutter Slope (%)	N/A
N/A	Gutter Lip Ht (in)	N/A	N/A	Gutter X Slope (%)	N/A
N/A	Painted X Walk1?	No	N/A	Painted X Walk2?	N/A
	X Walk 1 Direction	To NE		X Walk 2 Direction	N/A
N/A	X Walk 1 Width (in)	N/A	N/A	X Walk 2 Width (in)	N/A
	X Walk 1 Slope (%)	1.9		X Walk 2 Slope (%)	N/A
	X Walk 1 X Slope (%)	2.0		X Walk 2 X Slope (%)	N/A

Remove & Replace Entire Ramp.
