Access Compliance Report
Public Rights-of-Way
(Curb Ramps)

Intersection ID: 29571	Main Street: WHITEHALL_PARK_DR	Cross Street: ARCO_CORPORATE_DR	Location:	NW
ADA ID: 8430F5B44656	Ramp Type: PerpDiag	Initial Pass/Fail: Fail	Overall Compliance: No	Severity Score: 33.75

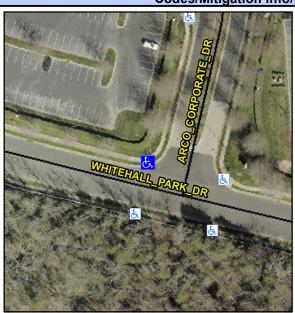
R304.5.1, R304.2.2, R304.5.3

Compliance	Description	Data	Compliance	Description	Data
N/A	Ramp Length (in)	47.5	No	Ramp Slope (%)	11.2
No	Ramp Width (in)	39.5	No	Ramp XSlope (%)	5.8
N/A	Flare Type LT	N/A	N/A	Flare Type RT	N/A
N/A	Flare Slope LT (%)	N/A	N/A	Flare Slope RT (%)	N/A
N/A	Flare Traversable LT?	N/A	N/A	Flare Traversable RT?	N/A
N/A	Landing Length (in)	N/A	N/A	DWS Provided?	N/A
N/A	Landing Width (in)	N/A	N/A	DWS Contrast?	N/A
N/A	Landing Slope (%)	N/A	N/A	DWS Length (in)	N/A
N/A	Landing X Slope (%)	N/A	N/A	DWS Full Width?	N/A
N/A	Landing Curb? (Y/N)	N/A	N/A	DWS Offset (in)	N/A
N/A	Shared Landing?	N/A			
N/A	Gutter Ponding?	N/A	N/A	Gutter Slope (%)	N/A
N/A	Gutter Lip Ht (in)	N/A	N/A	Gutter X Slope (%)	N/A
N/A	Painted X Walk1?	No	N/A	Painted X Walk2?	No
	X Walk 1 Direction	To SW		X Walk 2 Direction	To SE
N/A	X Walk 1 Width (in)	N/A	N/A	X Walk 2 Width (in)	N/A
	X Walk 1 Slope (%)	3.1		X Walk 2 Slope (%)	0.7
	X Walk 1 X Slope (%)	1.1		X Walk 2 X Slope (%)	8.2

Remove & Replace Curb Ramp With Two New Directional Ramps or Equivalent.
