Access Compliance Report
Public Rights-of-Way
(Curb Ramps)

Intersection ID: 47613 | **Main Street:** BATHURST_DR | **Cross Street:** MACQUARIE_LN | **Location:** NW

ADA ID: 846A90E4FD52 | **Ramp Type:** PerpDiag | **Initial Pass/Fail:** Fail | **Overall Compliance:** No | **Severity Score:** 12.5

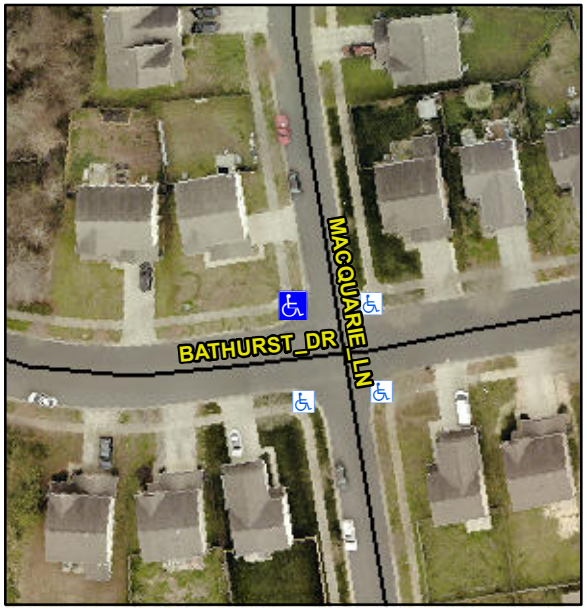
Not Found, R304.5.3

Compliance	Description	Data	Compliance	Description	Data
N/A	Ramp Length (in)	73.0	Yes	Ramp Slope (%)	5.5
Yes	Ramp Width (in)	48.0	No	Ramp XSlope (%)	6.8
N/A	Flare Type LT	N/A	N/A	Flare Type RT	N/A
N/A	Flare Slope LT (%)	N/A	N/A	Flare Slope RT (%)	N/A
N/A	Flare Traversable LT?	N/A	N/A	Flare Traversable RT?	N/A
N/A	Landing Length (in)	N/A	N/A	DWS Provided?	N/A
N/A	Landing Width (in)	N/A	N/A	DWS Contrast?	N/A
N/A	Landing Slope (%)	N/A	N/A	DWS Length (in)	N/A
N/A	Landing X Slope (%)	N/A	N/A	DWS Full Width?	N/A
N/A	Landing Curb? (Y/N)	N/A	N/A	DWS Offset (in)	N/A
N/A	Shared Landing?	N/A			
N/A	Gutter Ponding?	N/A	N/A	Gutter Slope (%)	N/A
N/A	Gutter Lip Ht (in)	N/A	N/A	Gutter X Slope (%)	N/A
N/A	Painted X Walk1?	No	N/A	Painted X Walk2?	No
	X Walk 1 Direction	To S		X Walk 2 Direction	To E
N/A	X Walk 1 Width (in)	N/A	N/A	X Walk 2 Width (in)	N/A
	X Walk 1 Slope (%)	0.0		X Walk 2 Slope (%)	3.3
	X Walk 1 X Slope (%)	6.6		X Walk 2 X Slope (%)	1.9

Remove & Replace Curb Ramp With Two New Directional Ramps or Equivalent.
