Access Compliance Report
Public Rights-of-Way
(Curb Ramps)

Intersection ID: 47301	Main Street: WOODRUFF_PL	Cross Street: HURSTON_CR	Location:	SW
ADA ID: 847FC6CB0EBA	Ramp Type: BlendTrans1	Initial Pass/Fail: Fail	Overall Compliance: No	Severity Score: 8.75

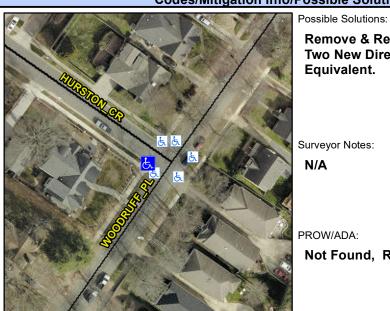
Not Found, R304.5.1

Compliance	Description	Data	Compliance	Description	Data
N/A	Ramp Length (in)	47.0	Yes	BlendTrans Slope (%)	2.2
No	Ramp Width (in)	47.5	Yes	BlendTrans XSlope (%)	1.5
N/A	Flare Type LT	N/A	N/A	Flare Type RT	N/A
N/A	Flare Slope LT (%)	N/A	N/A	Flare Slope RT (%)	N/A
N/A	Flare Traversable LT?	N/A	N/A	Flare Traversable RT?	N/A
N/A	Landing Length (in)	N/A	N/A	DWS Provided?	N/A
N/A	Landing Width (in)	N/A	N/A	DWS Contrast?	N/A
N/A	Landing Slope (%)	N/A	N/A	DWS Length (in)	N/A
N/A	Landing X Slope (%)	N/A	N/A	DWS Full Width?	N/A
N/A	Landing Curb? (Y/N)	N/A	N/A	DWS Offset (in)	N/A
N/A	Shared Landing?	N/A			
N/A	Gutter Ponding?	N/A	N/A	Gutter Slope (%)	N/A
N/A	Gutter Lip Ht (in)	N/A	N/A	Gutter X Slope (%)	N/A
N/A	Painted X Walk1?	No	N/A	Painted X Walk2?	N/A
	X Walk 1 Direction	To NE		X Walk 2 Direction	N/A
	X Walk 1 Width (in)	N/A		X Walk 2 Width (in)	N/A
	X Walk 1 Slope (%)	3.4		X Walk 2 Slope (%)	N/A
	X Walk 1 X Slope (%)	1.0		X Walk 2 X Slope (%)	N/A

N/A	Ramp inside XWalk1?	N/A	N/A	Ramp inside XWalk2?	N/A
	Road Slope (%)	1.0		Clear Space?	N/A
	Road X Slope (%)	3.4	N/A	Clear Space to XWalk (in)	N/A
N/A	Any Obstructions?	N/A	N/A	Storm Grate/Utility Hazard?	N/A
	Obstruction Type			Storm Grate/Utility Type	
N/A					N/A
			Yes	Surface Condition? (G/P)	Good
			No	Curb Slope (%)	10.3

Remove & Replace Curb Ramp With Two New Directional Ramps or Equivalent.
