Access Compliance Report
Public Rights-of-Way
(Curb Ramps)

Intersection ID: 46733	Main Street: DARCY_HOPKINS_DR	Cross Street: BEAVER_BROOK_WY	Location:	SE
ADA ID: 85044475A133	Ramp Type: Perp	Initial Pass/Fail: Pass	Overall Compliance: No	Severity Score: 10

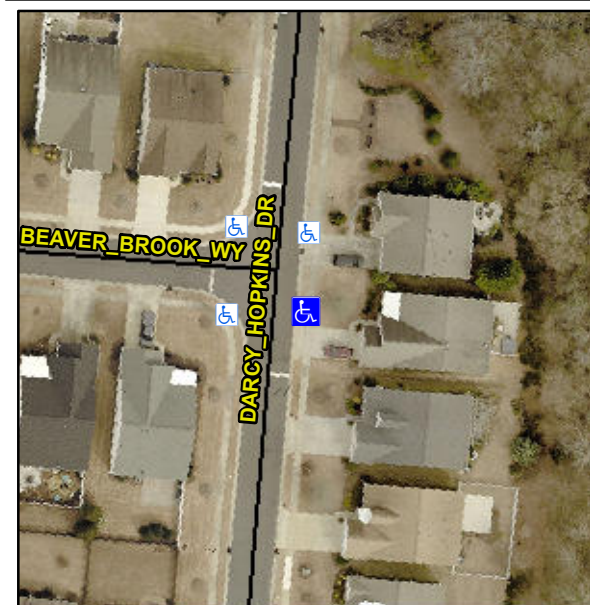
Not Found, R304.2.2-Perp, R304.3.2-Para, R305

Remove & Replace Entire Ramp.
